Re: Structural condition review and assessment  
Oyster River High School

Oyster River Cooperative School District  
**Oyster River High School**  
Structural review and assessment

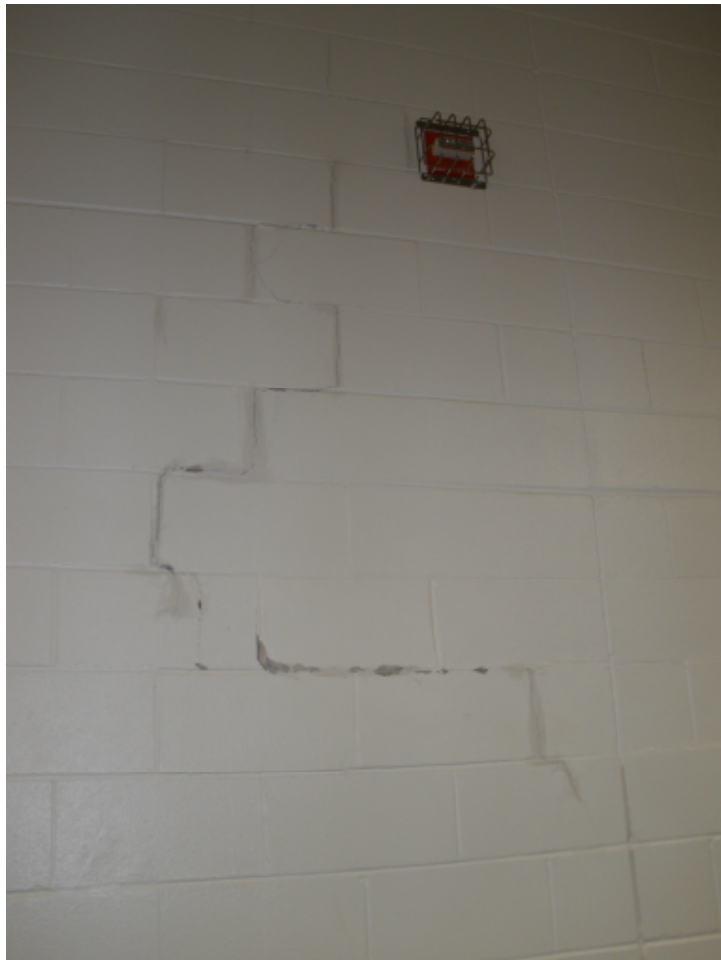
The crack observed in the north wall of the gymnasium occurs over the bleachers and extends upward to and through the fire alarm beacon on this wall. There is a vertical control joint in the masonry immediately adjacent to the crack, but the joint was ineffective at preventing the crack. It is likely that the horizontal wall reinforcement was extended across the control joint, rendering it ineffective.

Photo 1: Interior north wall of gymnasium at gym centerline: Step crack near fire beacon, above bleachers, does not follow the vertical control joint. (Control joint is visible at bottom right corner of this photo.)

3. AEC Audit, Page 33, third paragraph under "Structural Systems", regarding vertical wall cracks: FBRA is not certain which specific masonry wall crack location is referred to in this paragraph. This uncertainty may be caused by the apparent confusion over the compass orientation of the building. However, vertical masonry cracks fitting this description were observed by FBRA in the north wall of the gymnasium and also in the Athletic Trainer's office. These cracks may be due to minor settlement (as noted in the AEC Audit), or they may result from temperature and shrinkage stresses in combination with an inadequate control joint pattern. In either case, FBRA concurs with AEC that the cracks are most likely not moving or active at this time. The Facility Audit recommendation that the cracks be gauged and periodically monitored by a testing agency is appropriate. If this monitoring indicates that conditions are unchanged after a period of 1 to 2 years, then the cracks can be permanently repaired by re-pointing.

The cracks in the masonry walls in the gymnasium and trainer's room should be monitored to determine if they are "active" (still moving ) or static conditions. This monitoring should be done by a testing agency, over a period of two years. If there is no further evidence of movement, these cracks can be re-pointed. These cracks appear to be the result of temperature and shrinkage stresses, combined with inadequate control joint spacing and detailing. We observed only three such cracks in the building.

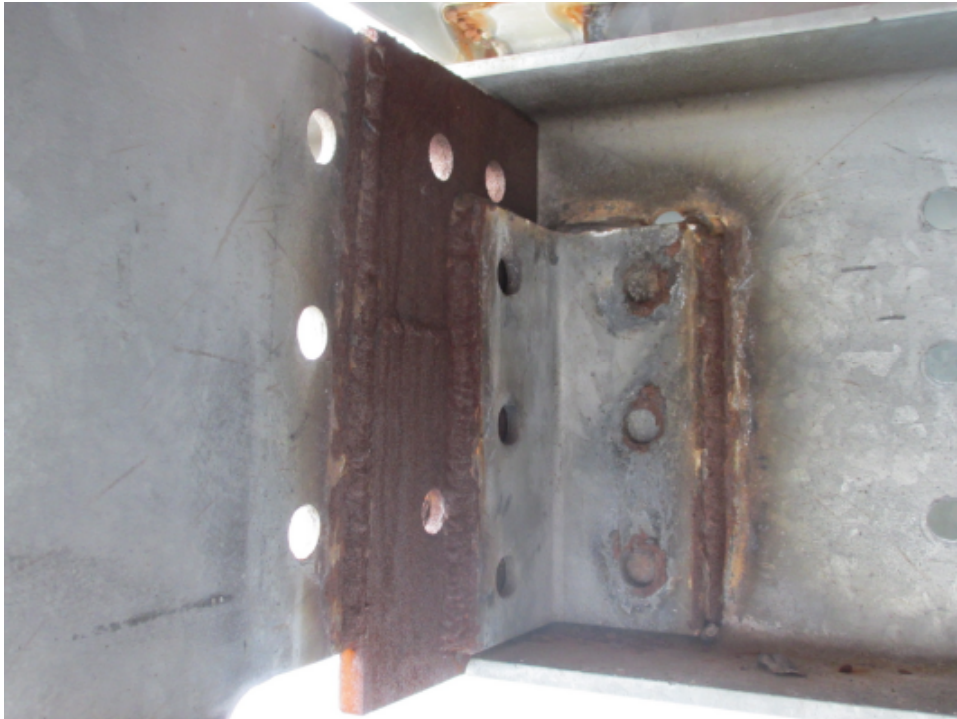
4. AEC Audit, Page 33, last paragraph, AHU-4 framing: FBRA generally agrees with the AEC Audit comments. It appears that the dimensions of the rooftop steel frame were not coordinated with the dimensions of the mechanical unit. (This may have been due to a late change in the unit size or manufacturer). In any event, the longitudinal beams supporting the north and south sides of the unit were installed at a wider spacing than what was indicated on the steel shop drawings. This was done to correctly align those beams beneath the long sides of the rooftop unit. The cross beam at the west end of the rooftop unit was fabricated too short (it would have been too short even if the original spacing dimension between the longitudinal beams had been correct.) Ten framing connections were field modified to correct these conditions. Modifications to these beams included adding a 6" long welded-on web extension to the short cross beam. The ten affected framing connections were originally intended to be bolted, but the dimensional modifications required that the final connections be field welded.

The welded modifications described above are judged to be structurally adequate, but they are poorly done with regard to their cosmetic appearance and corrosion resistance. The cosmetic appearance may not be a major concern given the location of this unit.

However the steel plate that was used to extend the short beam was not galvanized material. That plate now exhibits surface corrosion. The framing connections were originally intended to be bolted (not welded) because welding destroys the galvanized finish on the steel, leaving it susceptible to corrosion. The field adjustments to the frame dimensions made welded connections necessary. Typically, field welding of steel connections on galvanized AHU frames is discouraged for this reason. Corrosion is now evident to varying degrees in the welds and in the steel components in the vicinity of the welds.

Photo 2: Fabrication/MEP coordination error at AHU-4 RTU frame.

At this time, the corrosion is still superficial and the structural capacity of the frame has not been adversely affected. FBRA recommends hand tool cleaning of the connections and the beam extension plate, followed by field painting of the affected areas with a primer and finish coat compatible with galvanized steel finishes. If cosmetic improvement is a concern, then the existing connection welds should be ground smooth prior to painting.

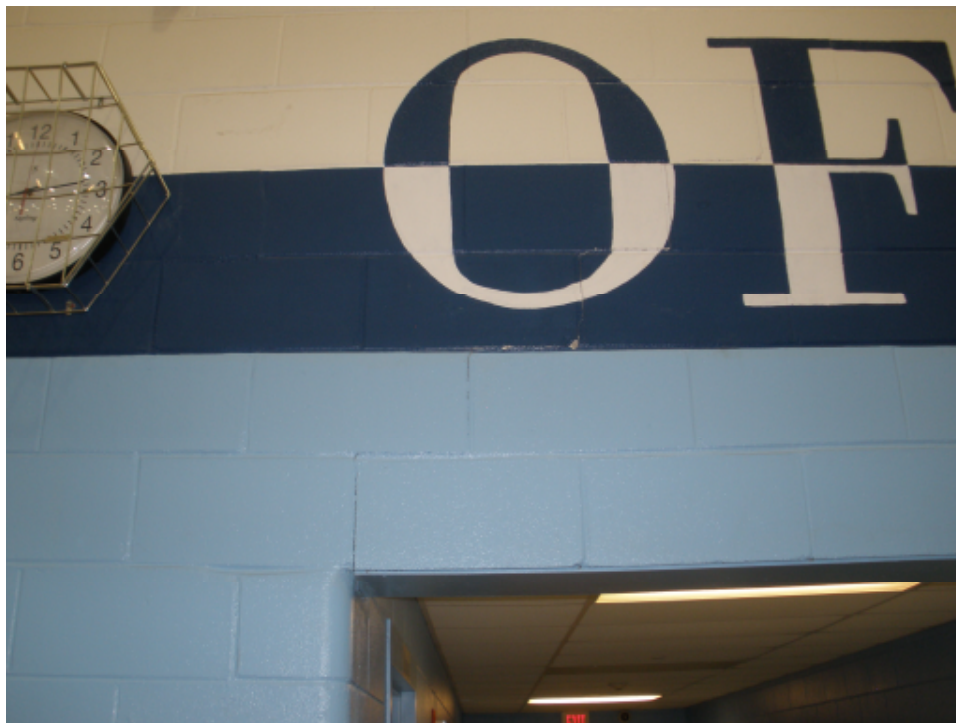
1. Interior masonry wall step cracks, south wall of gymnasium, over central entry portal: Viewing this entry portal from the gymnasium, there is a step crack emanating from the upper left corner of the portal opening, extending upward and to the right. In addition, there is one block over the right jamb where the face shell apparently was removed (or displaced) out of the wall and the unit has been reinstalled in the wall.

The step crack is evidently due to temperature and shrinkage stresses in this wall. This wall has vertical control joints located at the  $\frac{1}{4}$  and  $\frac{3}{4}$  points along its length, but there is no vertical control joint at the  $\frac{1}{2}$  point (near this portal). Note that the north wall of the gym has three equally spaced control joints, including a joint at the  $\frac{1}{2}$  point. In the absence of a control joint, the step crack occurred at the minimum wall section (the portal) to relieve shrinkage stresses. This crack is most likely static and accordingly we expect that it can be re-pointed with a low likelihood that it will reoccur.

Photo 3: Step crack over central entry portal in S wall of gym.

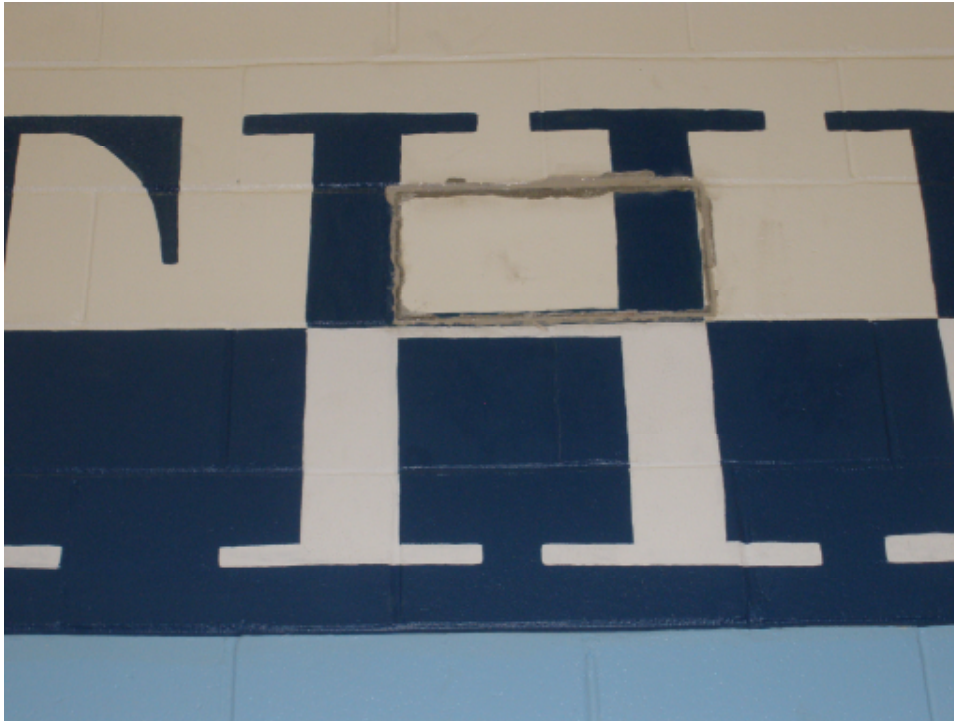
The reason for the displaced/repared face shell over the right jamb could not be ascertained during this assessment.

Photo 4: CMU repair over entry portal, S wall of gym.

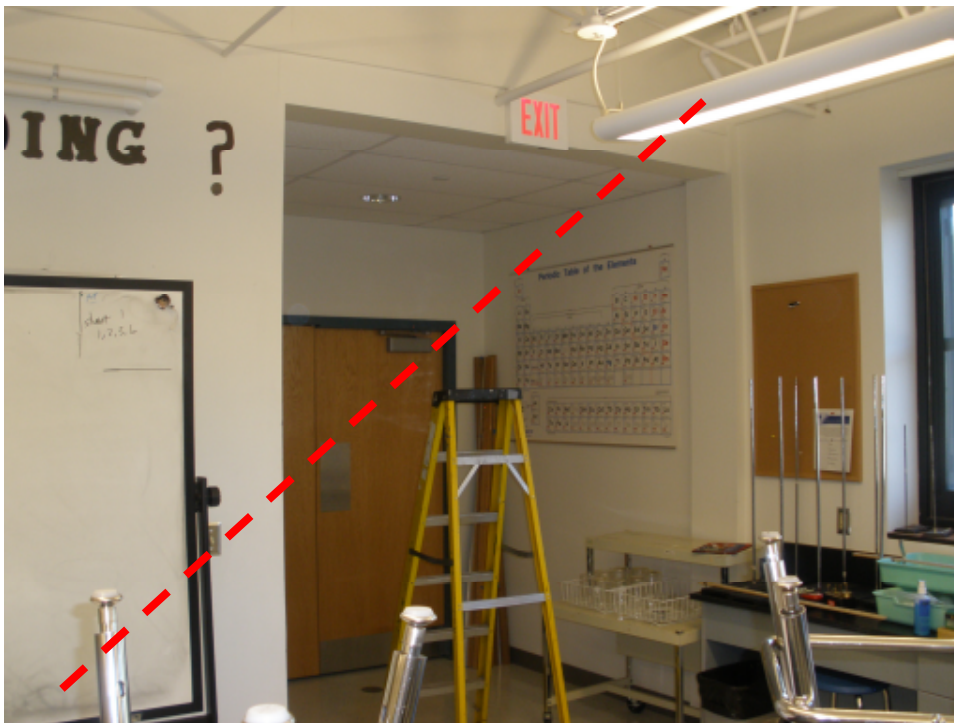
3. Area C laboratory classrooms – lateral bracing configuration anomalies: The science labs along the east exterior wall on both the first and second floor levels in Area C occur in pairs. Each pair of labs has a prep room between the two labs. The two labs and the prep room are linked by an alcove. The alcoves are along the exterior wall of the building, at the rear of each lab. The alcoves have double doors to provide for separation of the two labs.

According to the original structural drawings, column lines CG and CX in this area contain structural steel bracing bays. If the structural drawings were correct, the bracing diagonals would cut across the alcove entry and be visible (obstructions) in the finish work. No such bracing is in evidence in the finished building.

**Update:** Construction documentation on file at the SAU office includes sketch SKS-22; part of a change directive issued by the original Structural Engineer of Record. This sketch depicts the reconfiguration of these bracing bays to avoid the alcove openings. This issue is resolved.

Photo 5: Science lab: Diagonal brace at alcove not per construction drawings (relocation of brace was approved by the SER during construction).

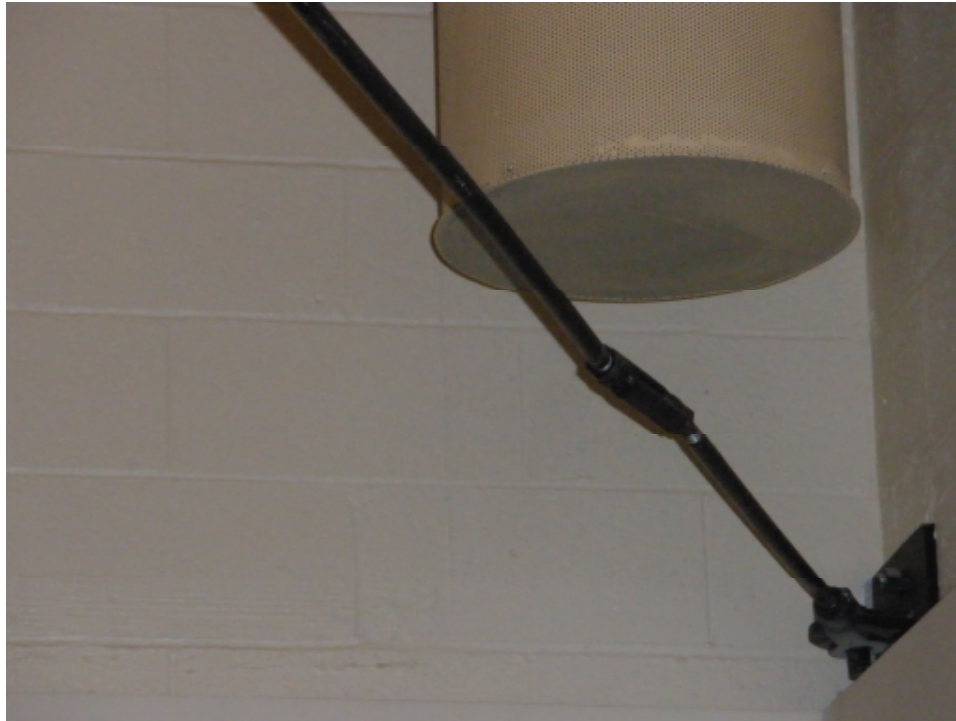
4. Library, SW corner, bent bracing rod at turnbuckle: The 2005 renovations included the addition of bracing rods to the glued laminated timber frames on the north and south sides of the pre-existing library. These rods are installed approximately 7 feet above the library floor. The rods are equipped with turnbuckles for adjustment purposes. One rod, located in the SW bay of the library, has a significant kink, occurring at the turnbuckle. This condition can and should be straightened, both as a structural and a cosmetic issue.
5. Typical rooftop Air Conditioning Condenser (ACC) unit supports. These units are installed on 4x4 pressure treated wood sleepers. The sleepers are approximately 8 feet long and the ends of the sleepers are bolted to a steel W6x25 sections that bear on rubber pads on the roofing membrane.

Photo 6: Kink in diagonal bracing rod at Library.

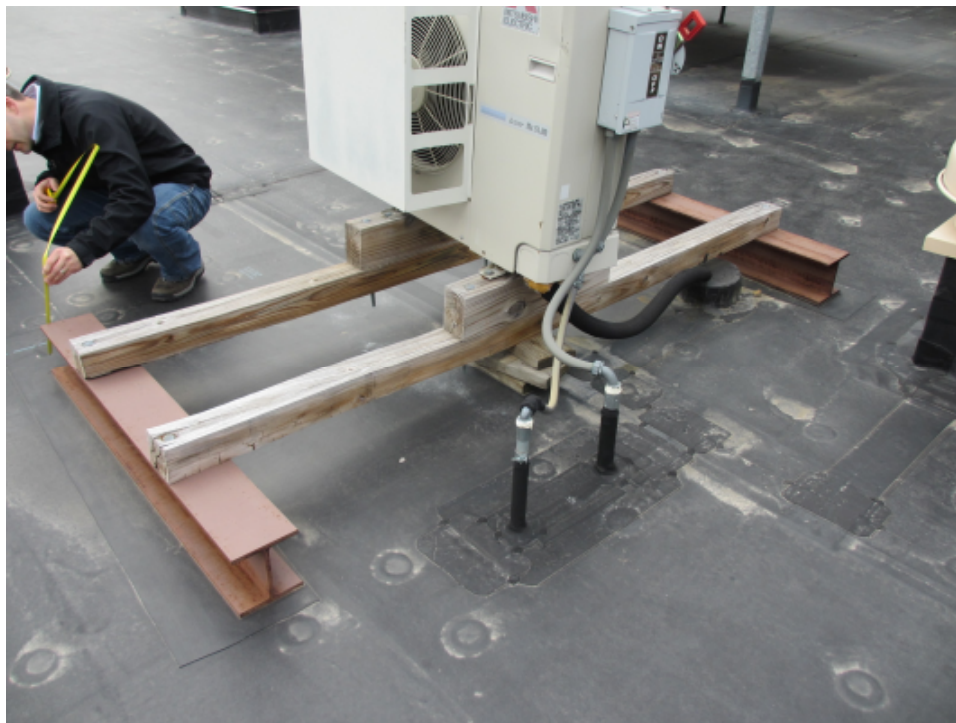
FBRA noted several instances where the 4x4 sleepers are split or sagging badly, and in one instance shims had been placed under the ACC unit because the 4x4 has essentially failed.

Photo 7: Typical rooftop ACC installation. Note shoring under wood sleeper. Installation has no positive attachment to the roof structure.

The entire assembly is not positively secured to the building roof and may therefore be vulnerable to wind storm damage. FBRA recommends that this support detail be reviewed by the original mechanical engineer to determine positive attachment to the roof is necessary. The support details for these units should be redesigned and modified to provide adequate support for the units.

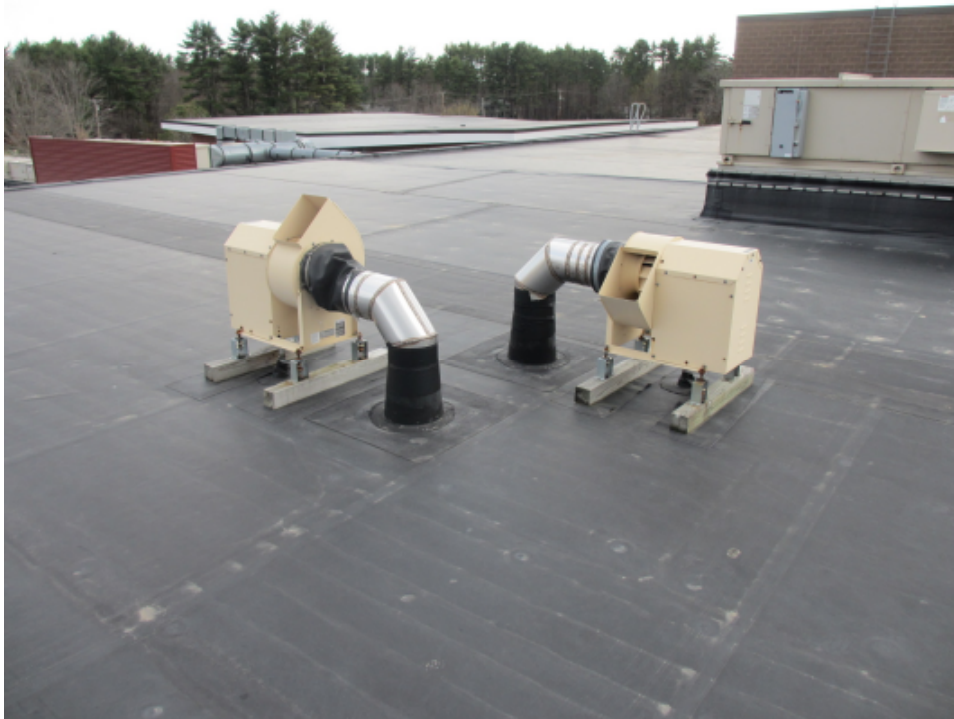
6. Typical rooftop Laboratory Exhaust Fan (LEF) supports. These fans are also supported on short lengths of 4x4 sleepers. The entire assembly can be lifted off the roof or laterally displaced by a single person.

Photo 8: Typical rooftop LEF installations, unsecured, on wood sleepers.

These units should be positively attached to the roof. The spring isolators that support these fan units are also irregularly installed.

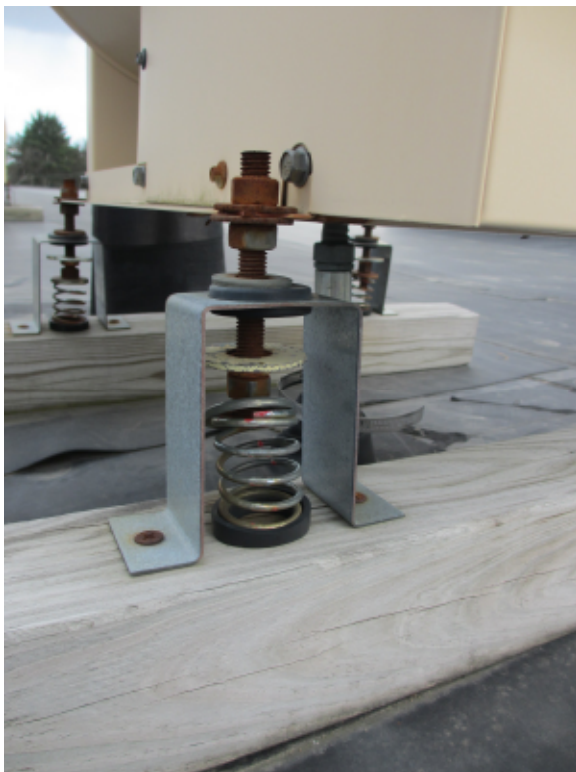
Photo 9: LEF spring isolator detail.

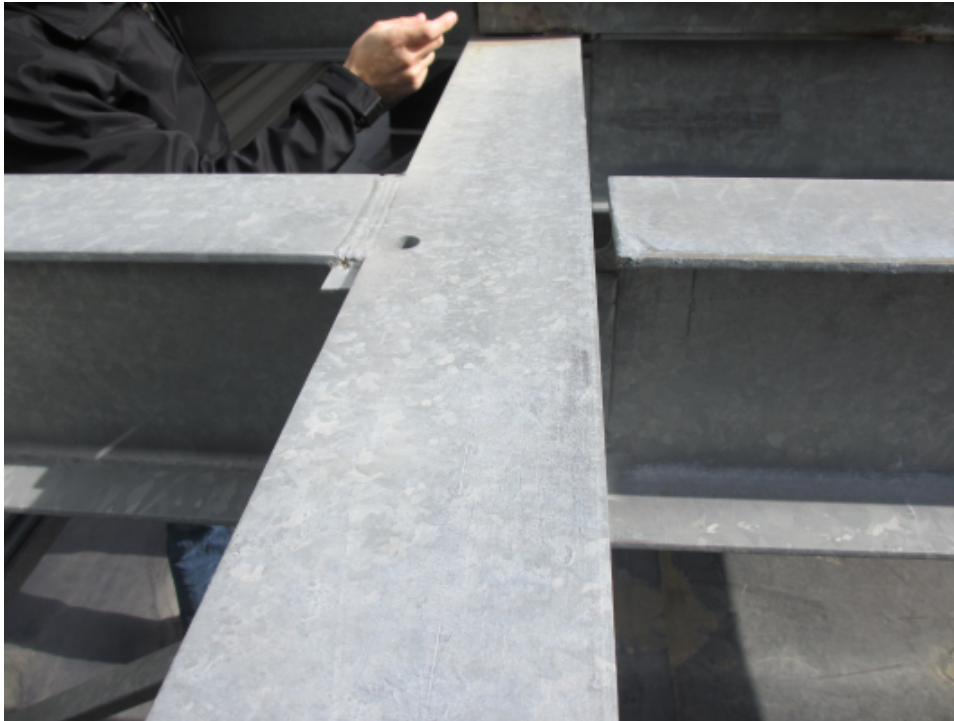
7. AHU-1 steel rooftop support frame screen. AHU-1 has a red metal panel screen on the east side of the unit. This is intended as a visual screen to conceal the unit. The unit sits on a structural steel support frame, and the screen cantilevers off of the support frame.

this brace exist at either end. Additionally, the horizontal cantilevered beams that support the screen are moment-connected (i.e., flanges are welded together) to the longitudinal beam that supports the east side of the AHU, but there are no similar moment connections attaching the backup beams to that longitudinal beam. As a result, the weight of the screen is carried by the longitudinal beam in torsion. It is doubtful that this was the designer's intent. The backup beams should also be moment-connected to the longitudinal beam.

Photo 10: Dunnage frame at AHU-1, cantilevered screen is to the left. Note moment connection (welded top flange) is provided for the beam coming in from the left, but is not provided on the beam to the right.

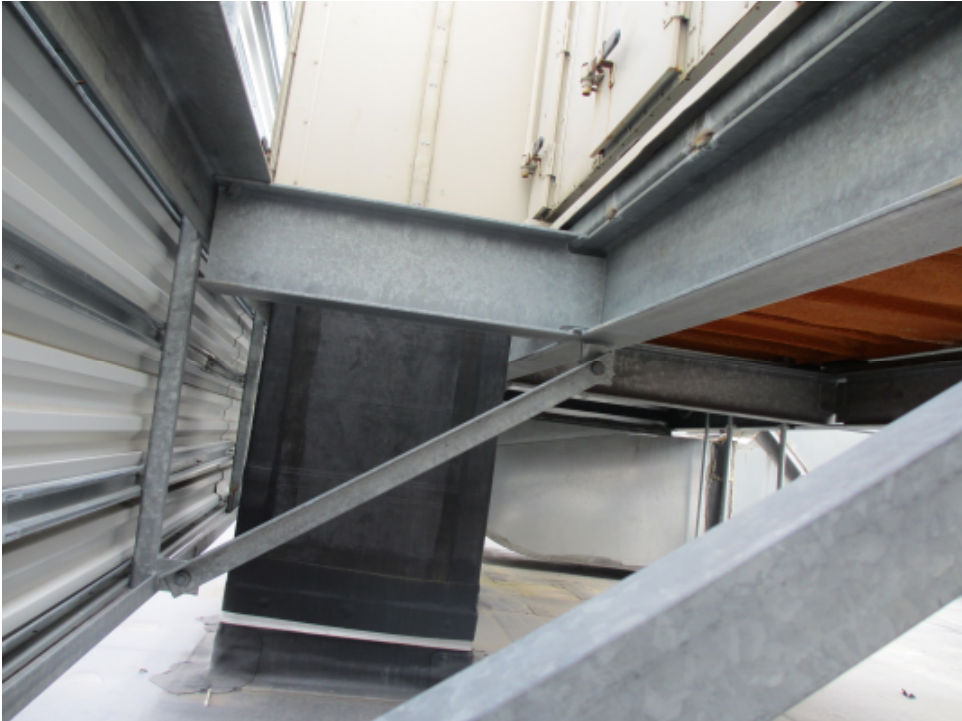
There are angle braces that extend from the bottom edge of the screen up to the east side of the AHU frame. The southerlymost angle brace is absent entirely, although the connection tabs for

Photo 11: AHU-1 rooftop frame – note bracing angle to bottom of screen.

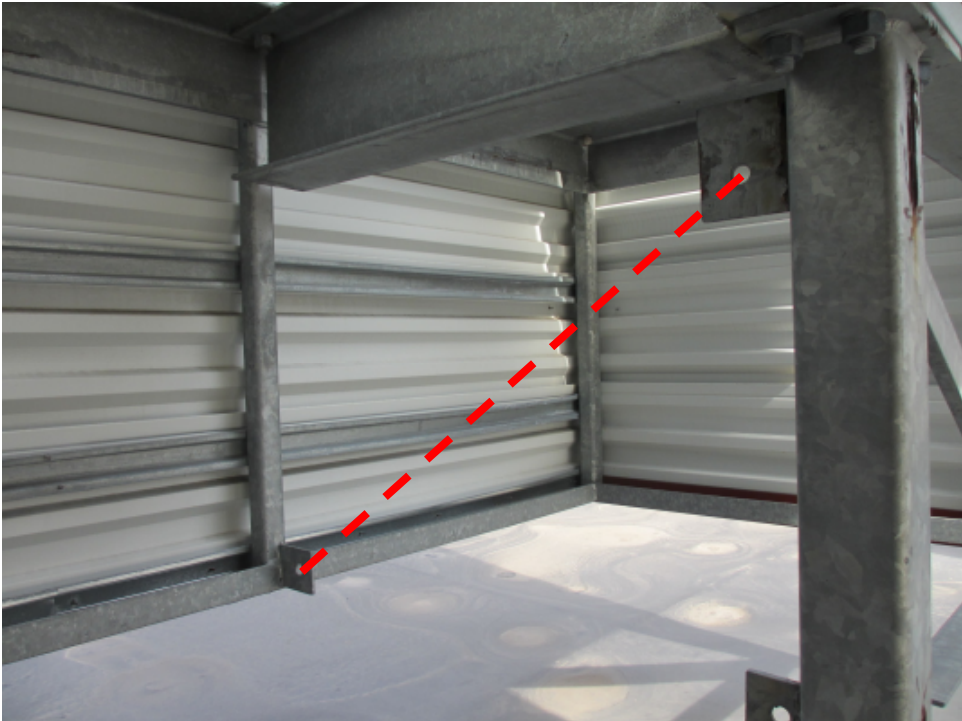
Photo 12: AHU-1 rooftop frame – note missing bracing angle.

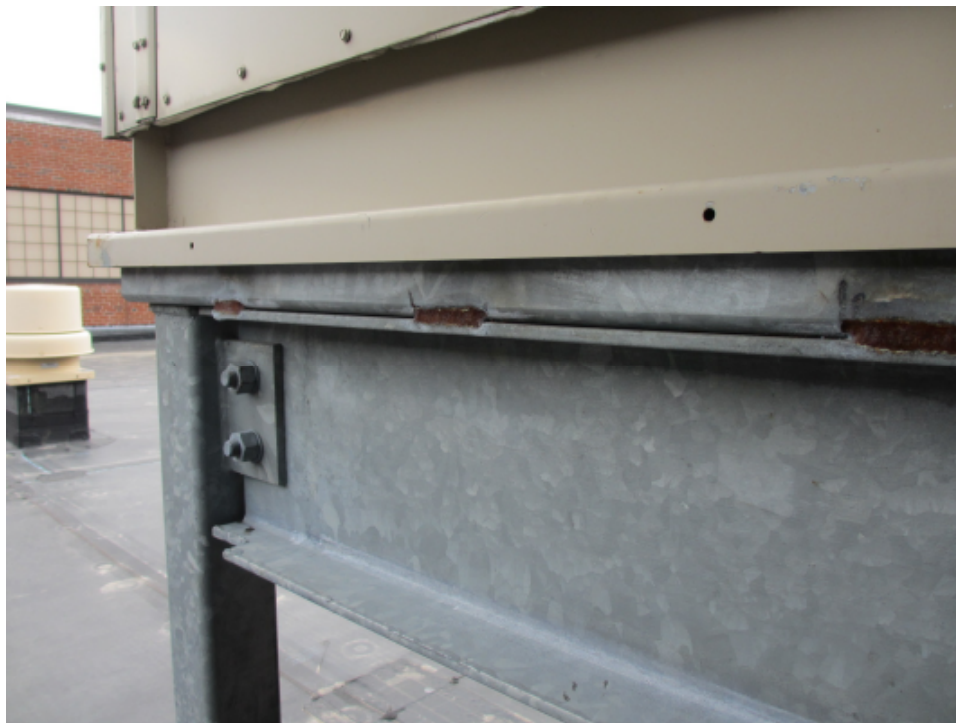
8. Rooftop AHU-to-frame welding for all units supported on steel support frame systems or curbs: Typically, the AHUs are welded to the supporting steel (or to curbs) with field welds spaced approximately 2 feet on centers. These welds should be treated with a zinc rich paint to protect them from corrosion.
9. South exterior wall of auditorium stage, SE corner, viewed from adjacent low roof: This wall has a 4" concrete masonry block exterior veneer. The lower courses in the vicinity of this corner and just above the low roof level have been re-pointed at least twice previously. This is probably due to a concealed issue within this wall involving the flashing or the drainage of the wall cavity. FBRA recommends consultation with a building envelope consultant on this issue.

Photo 13: Welds on AHU frames should be treated with zinc rich paint to retard corrosion.

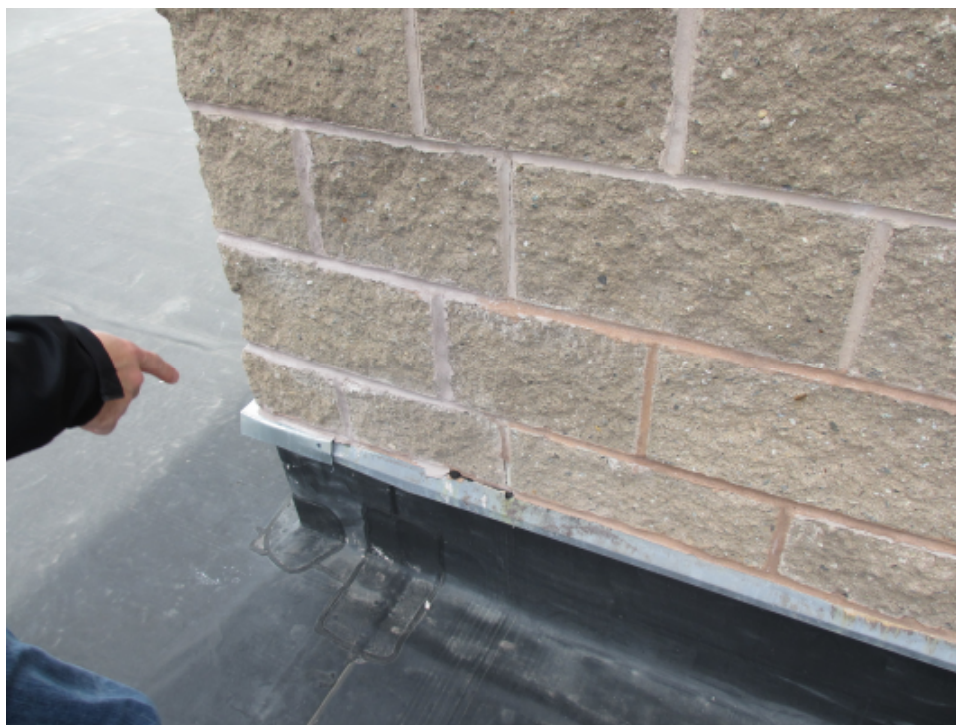
Photo 14: Exterior wall at SE corner of auditorium: CMU veneer has been re-pointed at least twice. This is likely indicative of a wall cavity drainage issue at this corner.

The veneer issues at the SE corner of the auditorium should be reviewed by an architect or a building envelope consultant.
