EMANUEL ENGINEERING, INC.

March 13, 2015

RE: Roof Snow Loads
Moharimet Elementary School
Oyster River Cooperative School District
Madbury, NH

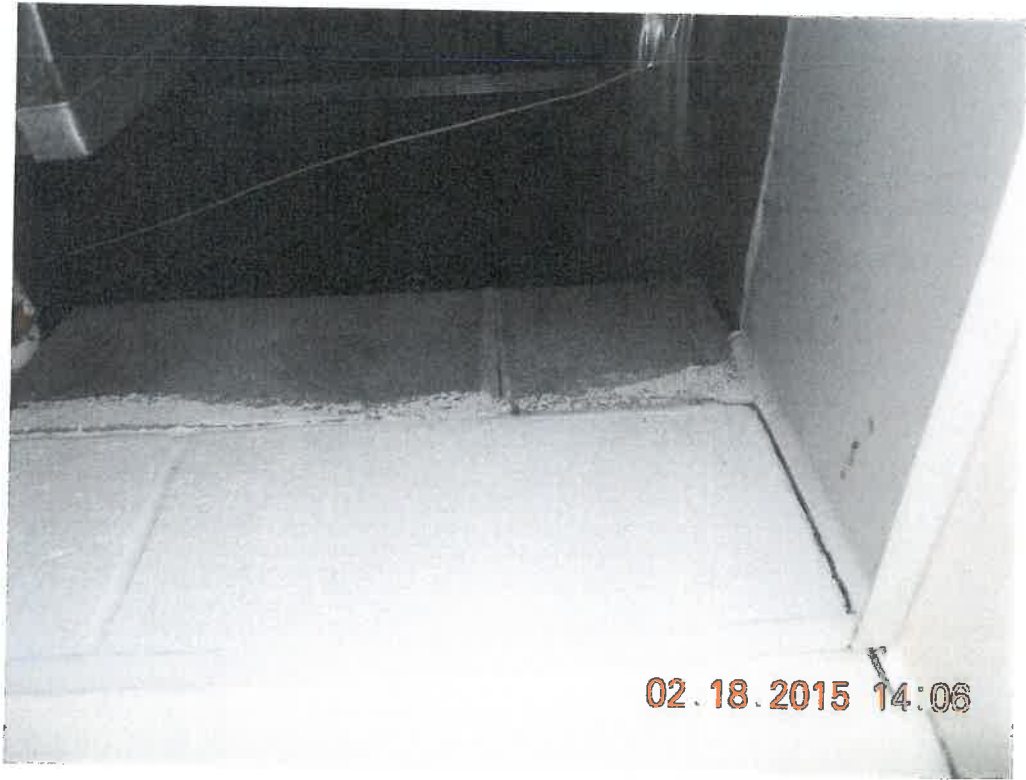
Non-load bearing masonry and stud wall.

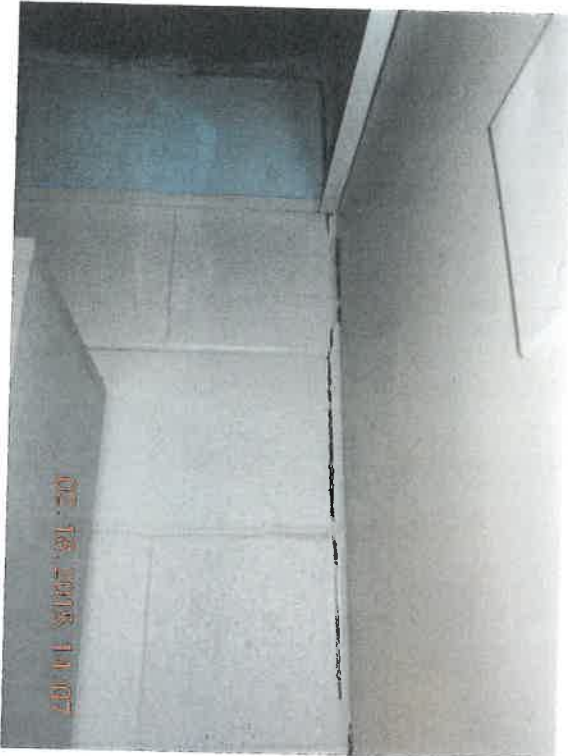
Room:	Observations – Comments:
155	Observed vertical crack at juncture of masonry wall and interior drywall face of the exterior metal framed wall. Both walls are non-load bearing and independent of each other. Believed to be unrelated to current snow load conditions and crack is not of structural significance. Concerned with snow loading resulting from snow piling against window units.

Room 155 - vertical crack at joint of 2 dissimilar walls

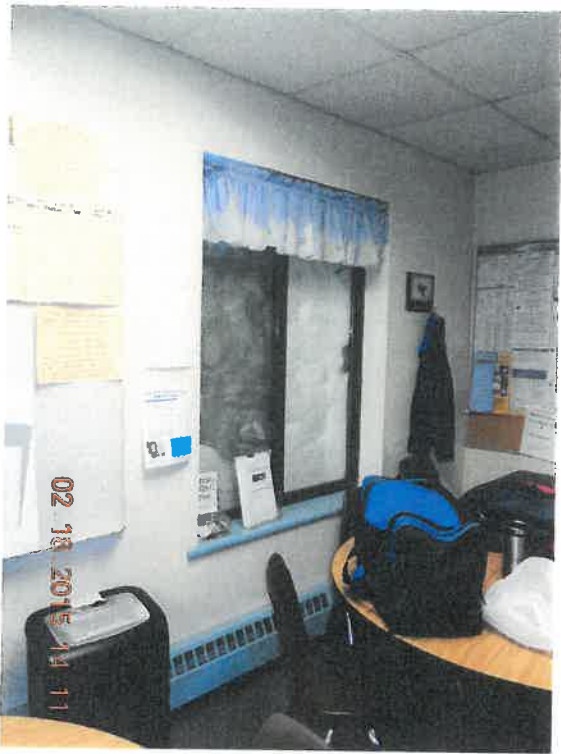
119	ceiling tiles more than normal. Sprinkler heads and stress cracks in drywall indicate snow loading and normal deflection, not damage to structural elements. No visible signs of structural distress.
Exterior Windows	Snow removed from the roof was piled close to the building and was observed against the building and exterior windows. Removing the snow from against the building and windows is highly recommended to prevent damage, breakage, and water leaking into the building.

Room 155 - snow stacked against window

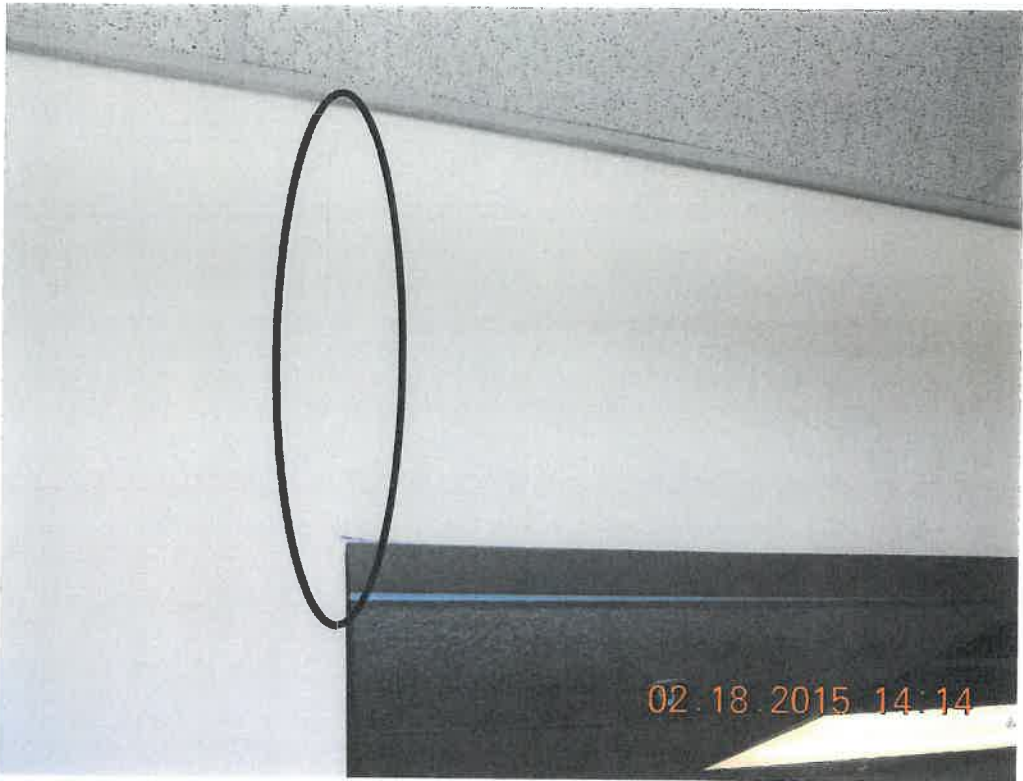
Typical drywall soffit crack

- Drywall cracks may be repaired but will reoccur when excessive snow loads occur on the roof unless the light gage metal framing is modified by using proper deflection tracks at the top of the wall above the observed cracks.
- All roof drains shall be kept free of snow to allow for snow melt.

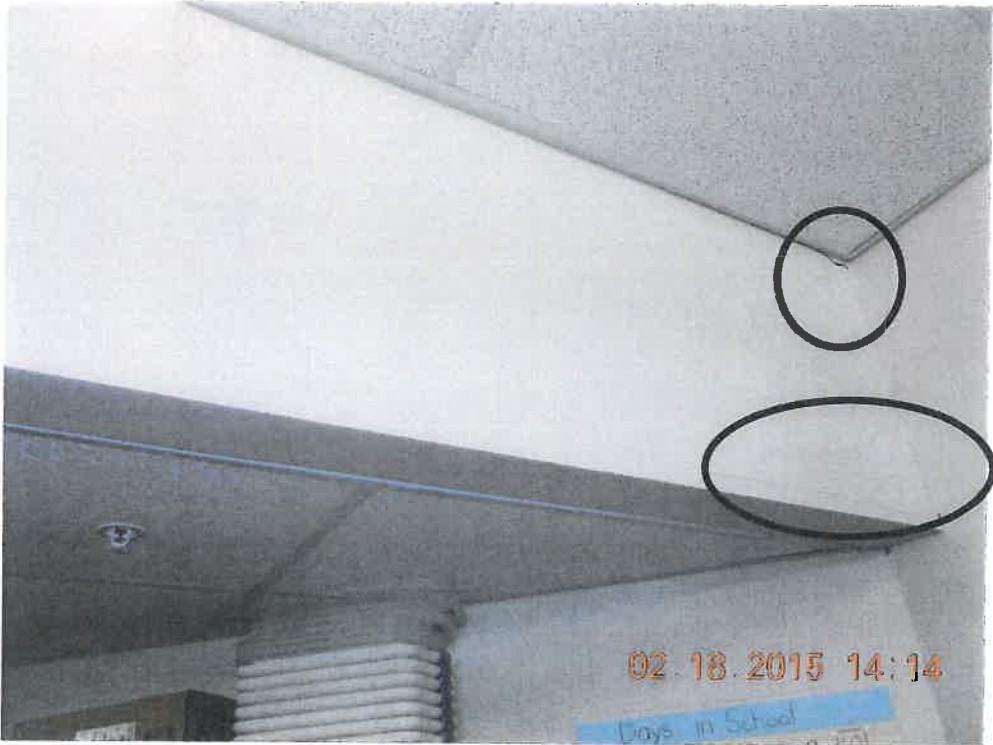
130	Drywall cracking in corners of soffit opening, non-load bearing wall. Drywall track was fastened directly to the roof bar joists without using proper deflection track. Soffit cracks indicate snow loading and normal deflection of bar joists, not damage to structural elements. Snow was removed from roof area above prior to arrival. No visible signs of structural distress.
137	Drywall cracking in corners of soffit opening, non-load bearing wall. Drywall track was fastened directly to the roof bar joists without using proper deflection track. Cracks indicate snow loading and normal deflection of bar joists, not damage to structural elements. Snow was removed from roof area above prior to arrival. No visible signs of structural distress.
138	Drywall cracking in corners of soffit openings and corners of non-load bearing wall. Fire protection sprinkler heads escutcheons protruding below ceiling tiles more than normal. Drywall track was fastened directly to the roof bar joists without using proper deflection track. Sprinkler head movement and stress cracks in drywall indicate snow loading and deflection of bar joists, not damage to structural elements. No visible signs of structural distress.

Room 130 - drywall crack

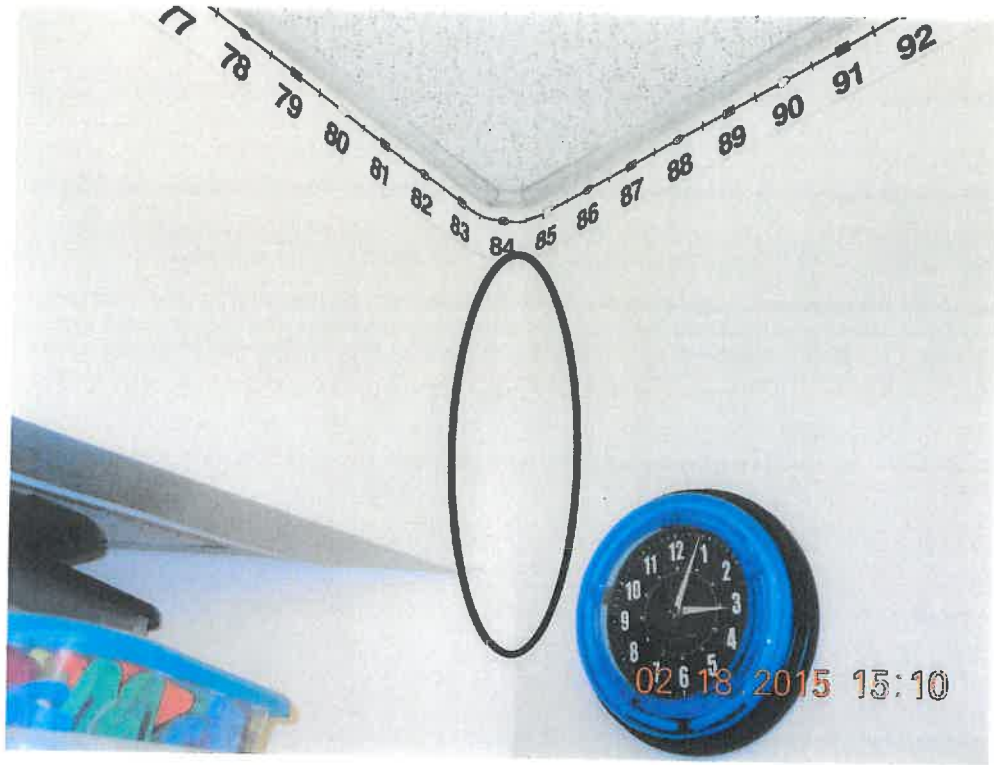
Crack

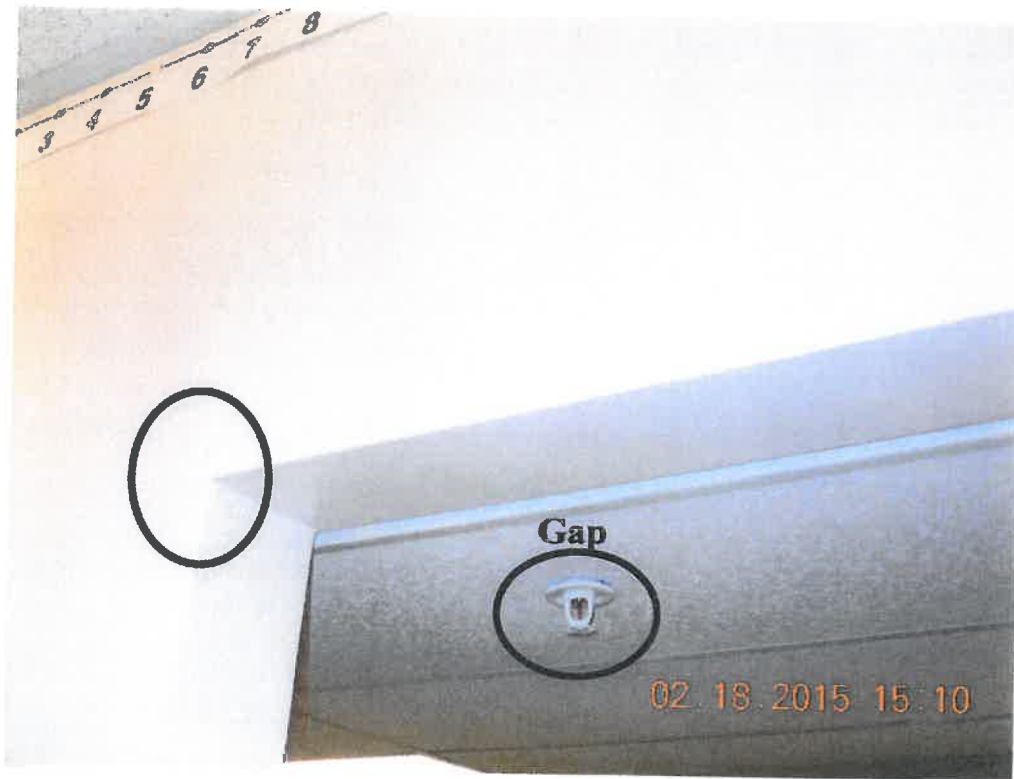
Drywall stress crack

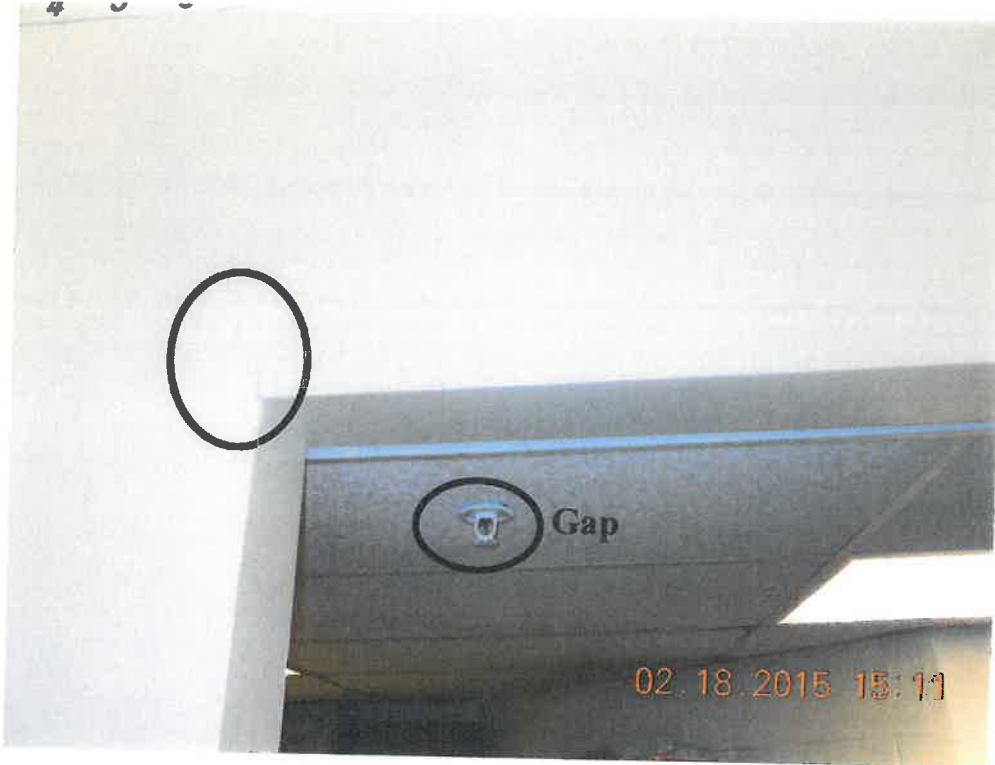
Drywall stress crack

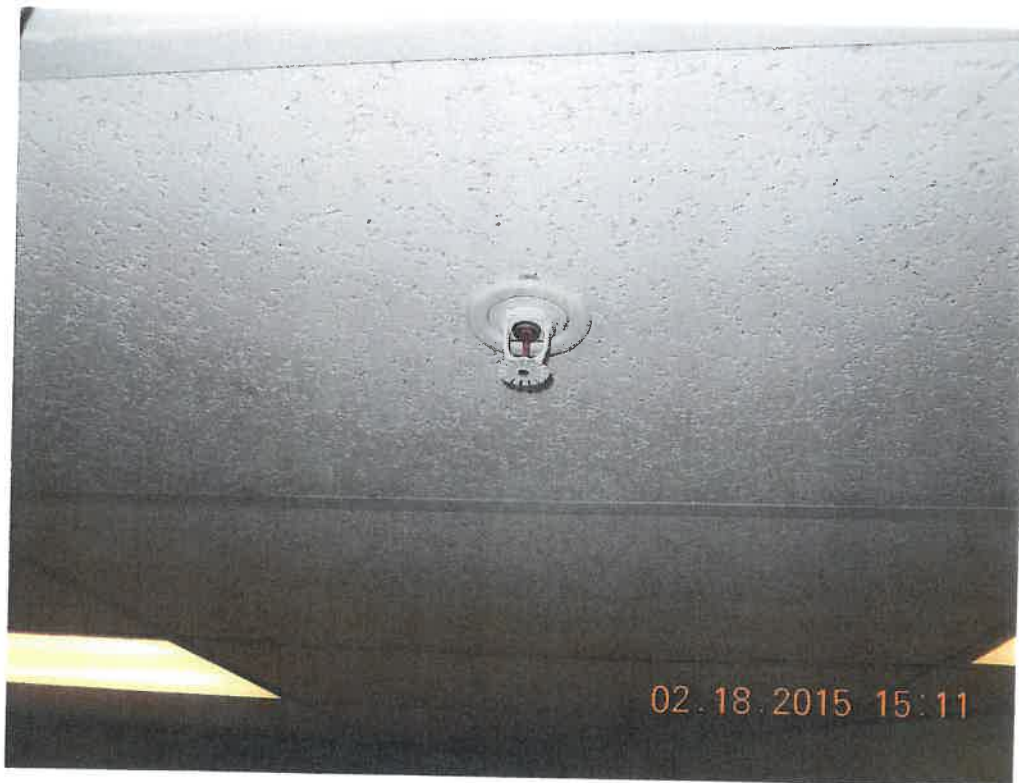
**Head protruding
below tile**

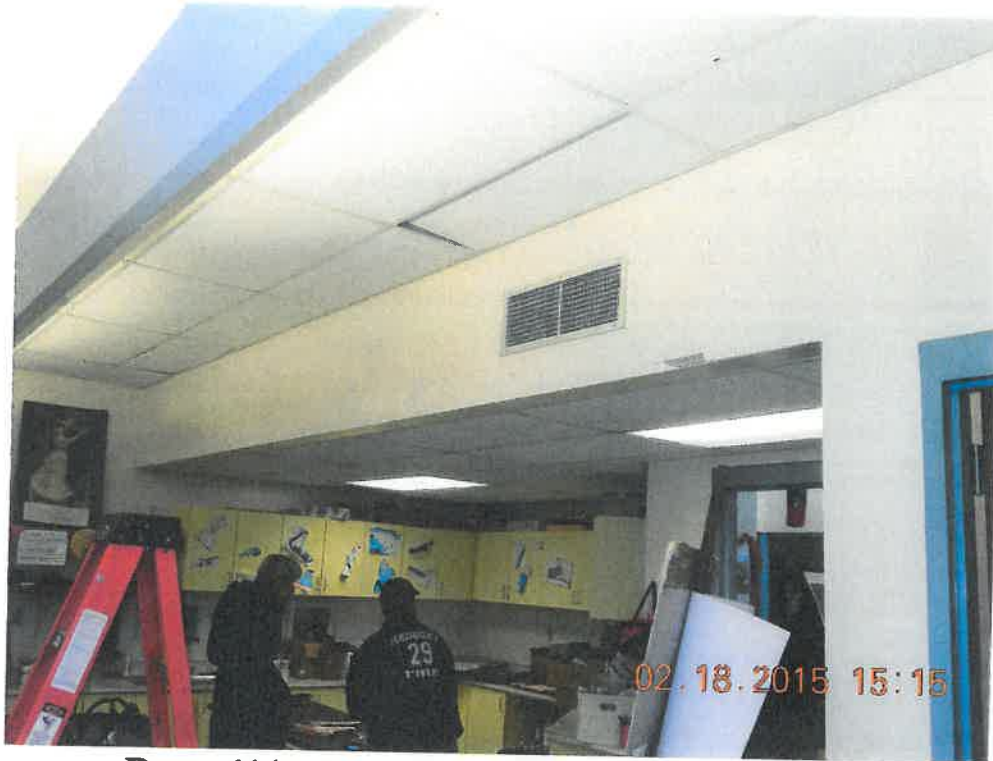
114	Stress cracks in drywall were observed around HVAC ductwork. Drywall track was fastened directly to the roof bar joists without using proper deflection track. No signs of structural distress.
118	Stress cracks in drywall were observed in wall at a drywall opening and around HVAC ductwork. Fire protection sprinkler head escutcheons protruding below ceiling tiles more than normal. Sprinkler heads and stress cracks in drywall indicate snow loading and normal deflection of bar joists, not damage to structural elements. No visible signs of structural distress.
East Commons	Snow observed above skylight windows indicating heavy load in recessed roof area. Measurements were taken from the building interior floor elevation to the bottom of exposed steel bar joists. No notable deflections were observed. No signs of structural distress.
119	Stress cracks in drywall were observed in wall at a drywall opening and around HVAC ductwork. Ceiling track was observed to be slightly deformed at the wall. Fire protection sprinkler head escutcheons protruding below

**Room 114 - drywall cracked at HVAC opening
caused by roof joists movement.**

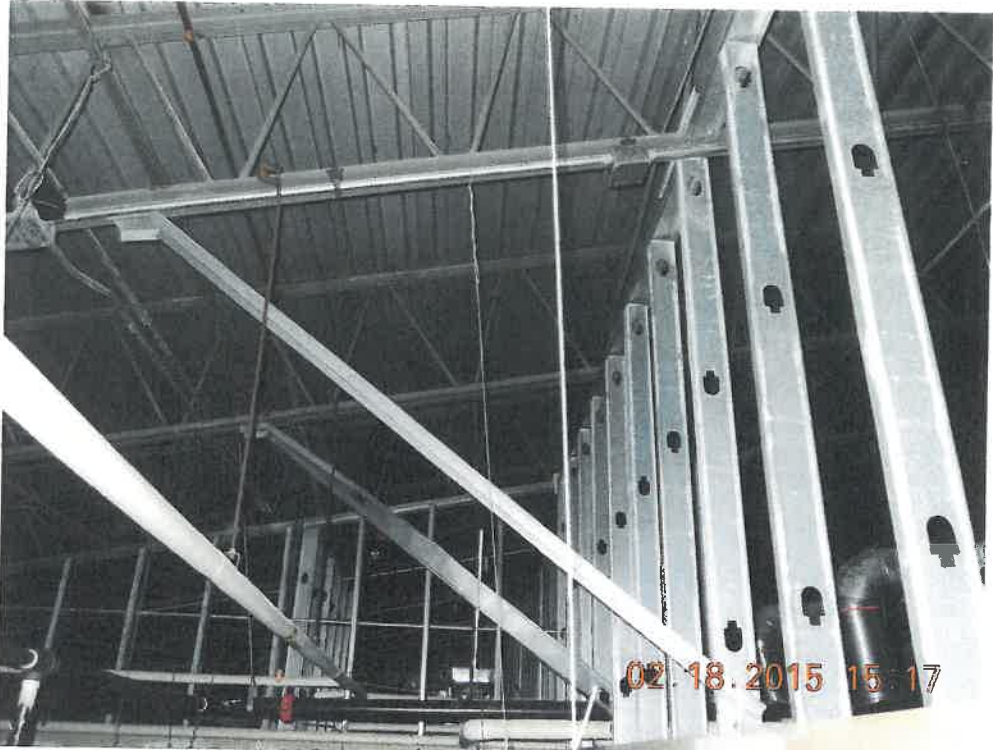
Wall studs and tack connect to roof joist.

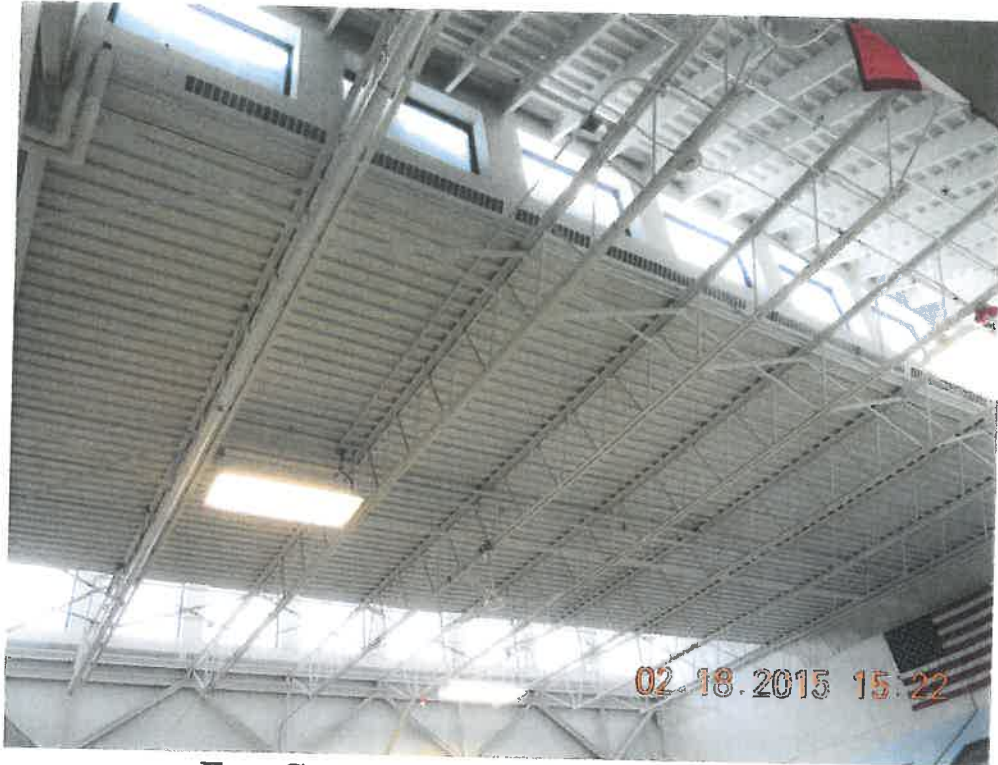
**East Commons - roof joists exhibited
and measured no significant sag.**

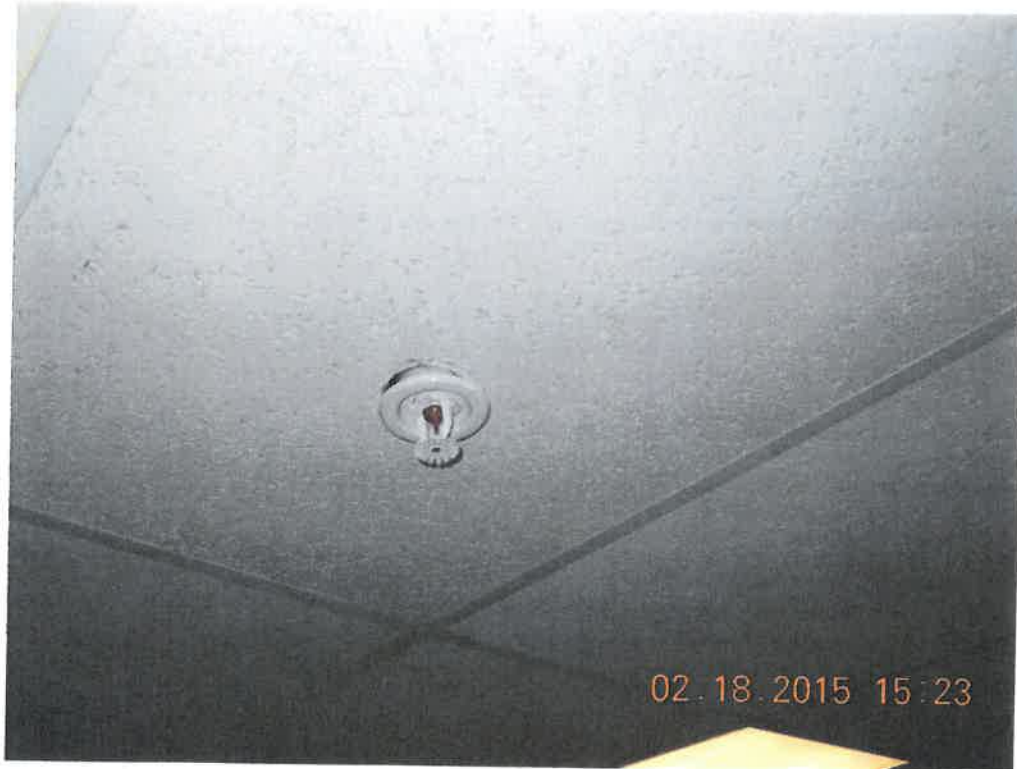
Sprinkler head moves downward as roof joists deflect downward.

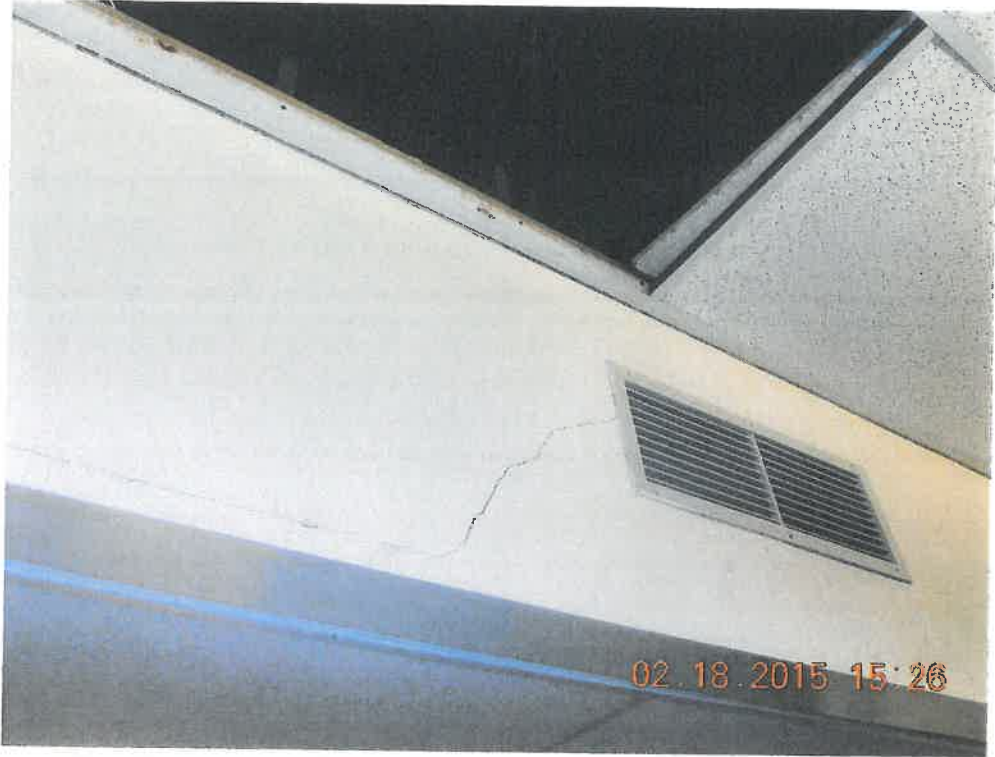
Cracked drywall caused by improper deflection track.

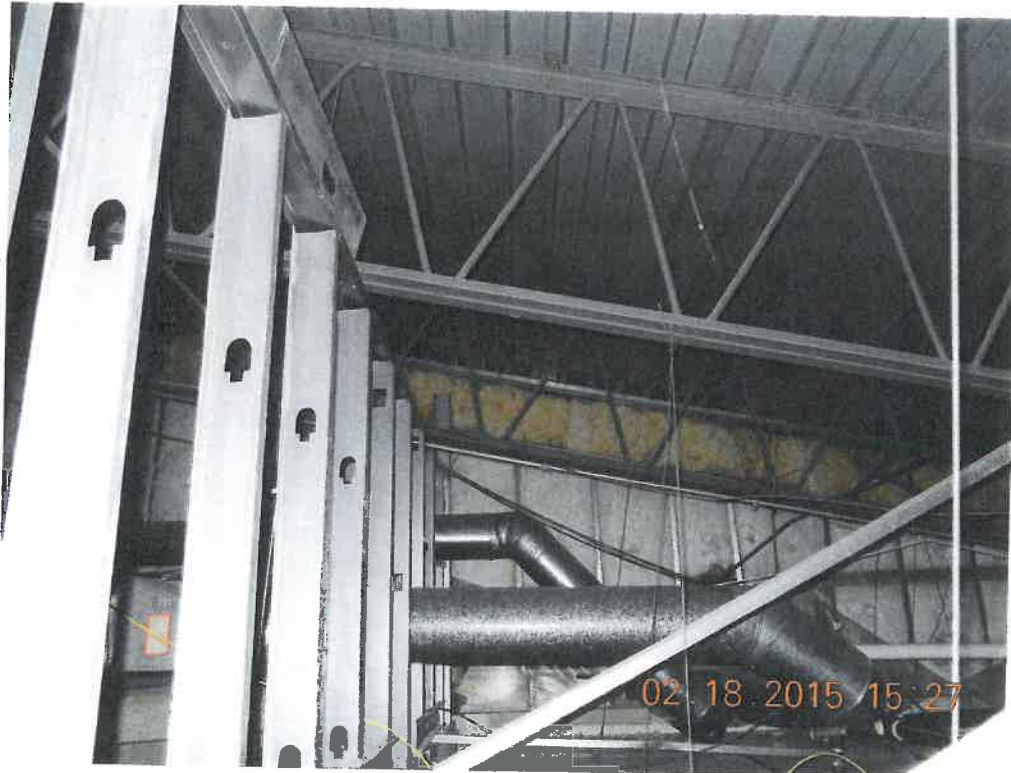
Wall track fastened directly to steel bar joist.

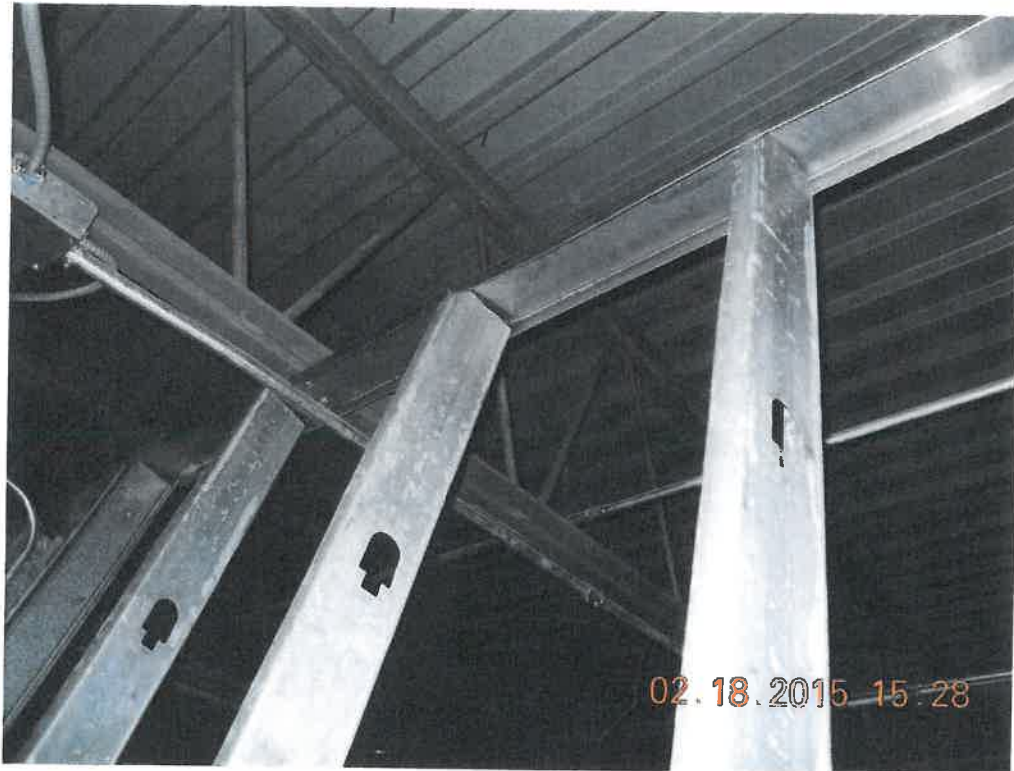
Metal stud wall allows for no movement of roof joists.
