OYSTER RIVER COOPERATIVE SCHOOL DISTRICT

Facilities & Program Analysis

DAVIS GOUDREAU
ARCHITECTS

FACILITY & PROGRAM ANALYSIS

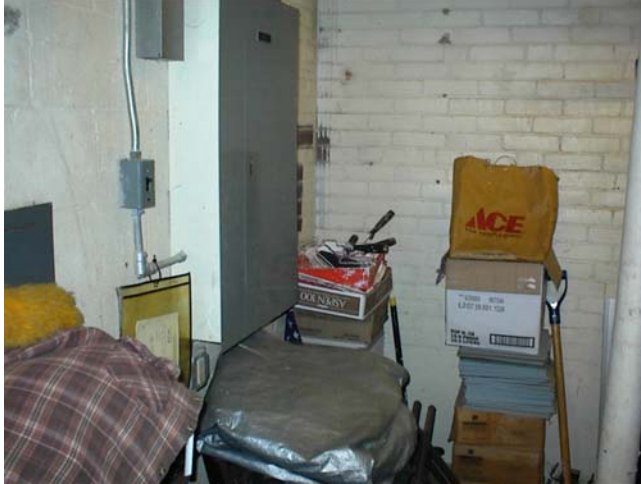
The main electric room B04 is presently utilized as a storage room (see photo #1) below. In violation of N.E.C. Article 110.26(B), all non electrical equipment should be removed from the electrical rooms. The main electric room door swings inward to the room and also is not equipped with panic hardware as required by N.E.C. Article 110.26(C)(2).

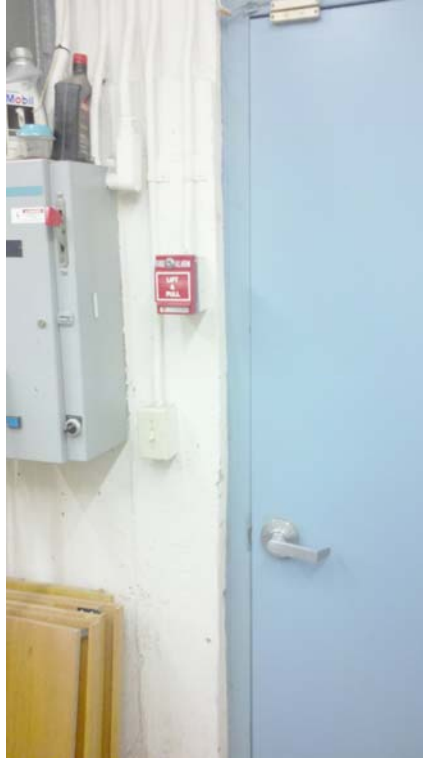
Photos #6 & 7

It appears that most of the buildings electrical controls and fire alarm devices are in compliance with the height and access requirements of the Americans with Disabilities Act and the State of New Hampshire Architectural Access Barrier Board requirements. We did observe some lighting control switches that were mounted above the allowed height for switch controls. We also observed that a few manual stations and audio/visual devices are not mounted at ADA compliant heights. See photos #6 and #7

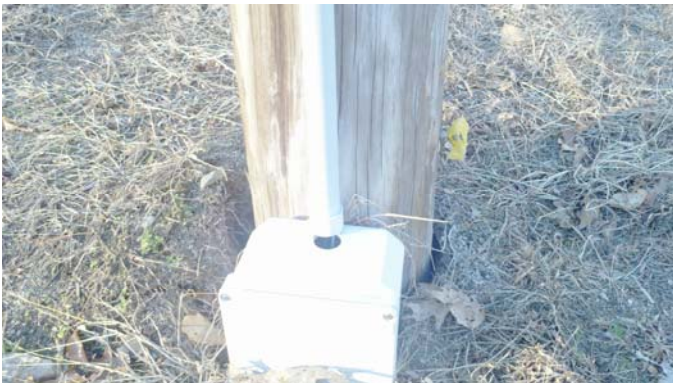
H.I.D. type, lensed, pole mounted floodlight luminaires illuminate the main parking lot and access drive around the building. These fixtures are owned and maintained by PSNH. As we performed our inspection during the daylight hours, we cannot comment on the adequacy of the exterior lighting levels however, there does not appear to be enough luminaires to provide adequate security lighting. The floodlight fixtures appear to be in fair condition. There are two locations where the pole mounted riser conduit has broken away from the junction box, exposing the wiring to physical damage. See photos #8 and #9.

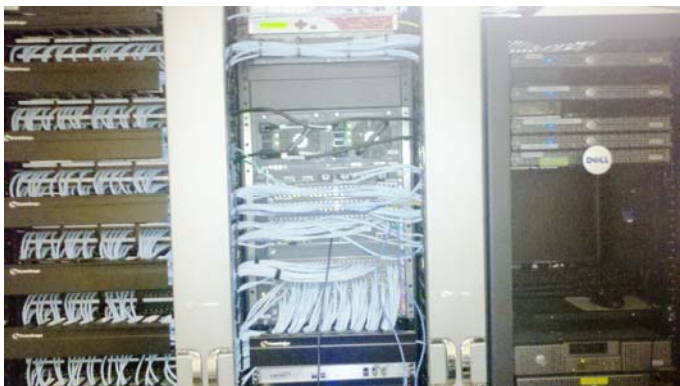
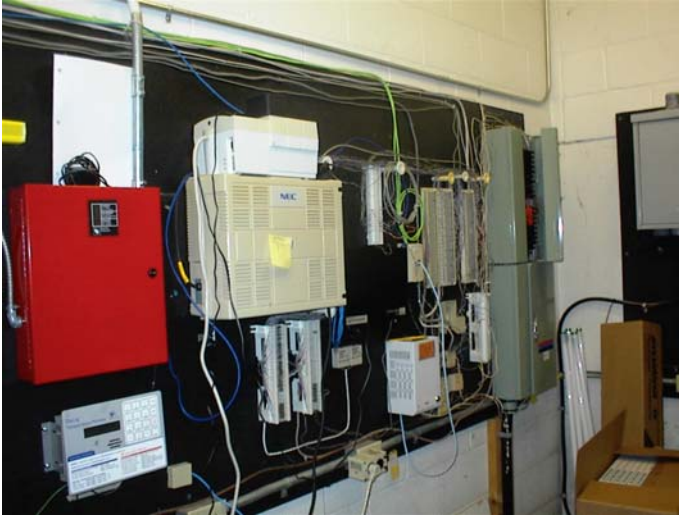
Incoming voice conduits emanate from PSNH pole #318A-4 and run underground into the main electric room 165. The server room is located in room #147. Data cabling is category 6 and the server rack, patch panels and data wiring all appear to be in excellent condition and fairly new. See photos #10 and #11.

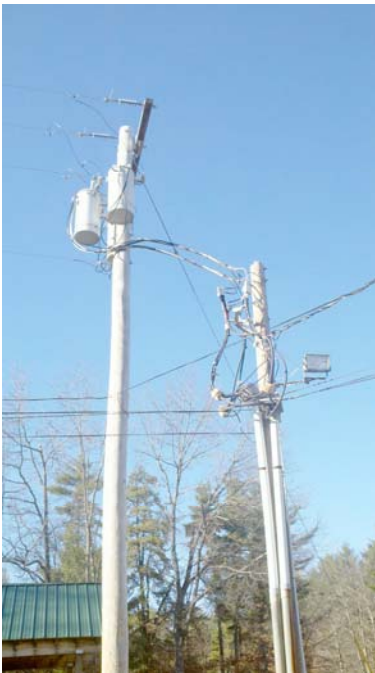
Photo #1

Building electrical power emanates from outdoor NHEC pole mounted distribution transformers located on NHEC pole #12A-14A2 at the rear of the building. The 3 distribution transformers are rated for 50 KVA each with an input voltage of 13,800 volts delta and an output voltage of 120/208 volts wye. The secondary service entrance conductors for the building run underground from the pad mounted distribution transformer to the main distribution panel located in the first floor main electric room #58A. NHEC presently owns and maintains the primary electric service feeder, and the pole mounted transformers, as the building is secondary metered by NHEC.

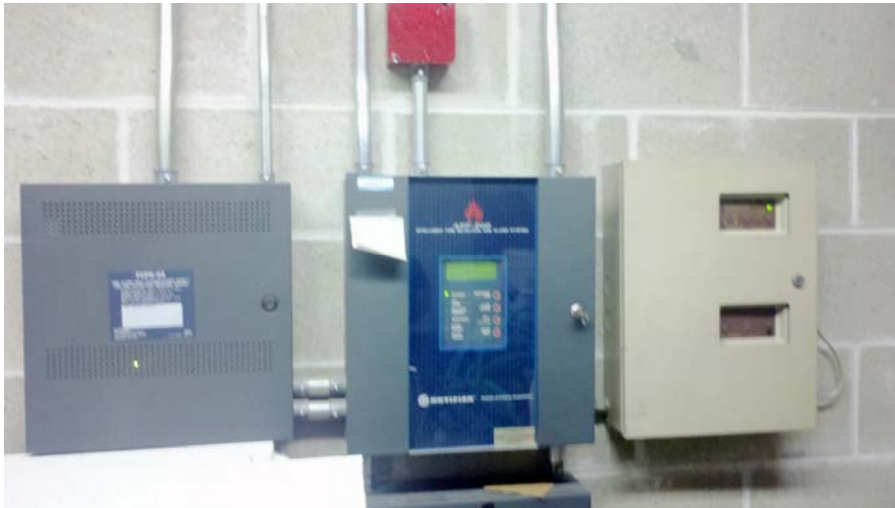
Photo #5

The main building is presently equipped with an addressable, low voltage fire detection and signalling system (Notifier AFP). The existing Fire Alarm System consists of a main control panel located in the main Electrical Room #58A and remote system indicating and initiating devices including manual pull stations located at egress points throughout the building. Audio visual horn/strobe units are also strategically located throughout the complex and smoke or heat detectors are located in corridors and open areas of the building. We did not observe any smoke detectors in the classrooms. The Notifier addressable system appears to have been installed in the last 10 years along with new addressable initiating and indicating devices. The audio/visual device coverage appears to comply with current NFPA 72 spacing requirements. There is an Adenco digital communicator which is located in the main electrical room. The digital communicator is tied into the fire alarm system and will notify the monitoring company of any "alarm" and/or "trouble" signals in the system. See photo #5.
