RE: Roof Snow Loads
SAU #5 Office Building
Oyster River Cooperative School District Buildings
Durham, NH

At your request, Emanuel Engineering, Inc. visited the Oyster River School District Office Building located at 36 Coe Drive, Durham, NH on February 18, 2015, to investigate possible roof problems due to snow loads on the roof. Dave Emanuel and I met with you on site. This report summarizes our observations and recommendations.

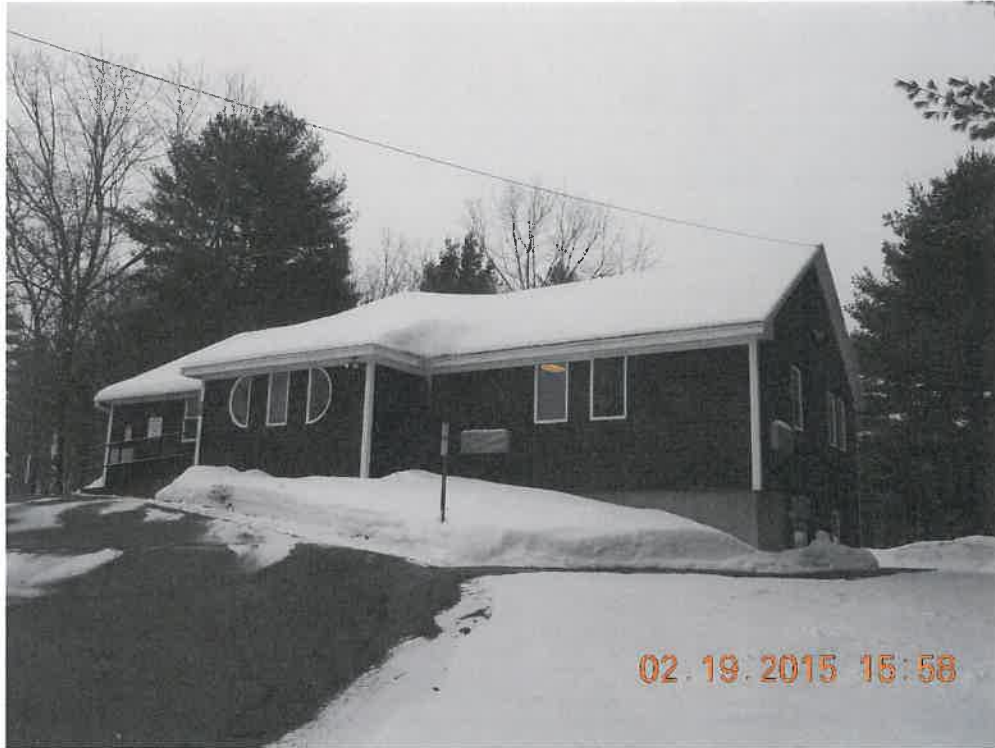
SAU #5 Office Building

There was no apparent over burdening snow load on the single-story, wood framed building at the time of the visual inspection from the ground. Building plans of the building were not provided by the School District nor reviewed for design loads.

Based on the day of the visit, snow depths were within allowable depths.

Without further additional review, calculations, or inspections, we recommend that snow depths on the office building roof not exceed 24 inches.
