OYSTER RIVER COOPERATIVE SCHOOL DISTRICT

Facilities & Program Analysis

DAVIS GOUDREAU
ARCHITECTS

FACILITY & PROGRAM ANALYSIS

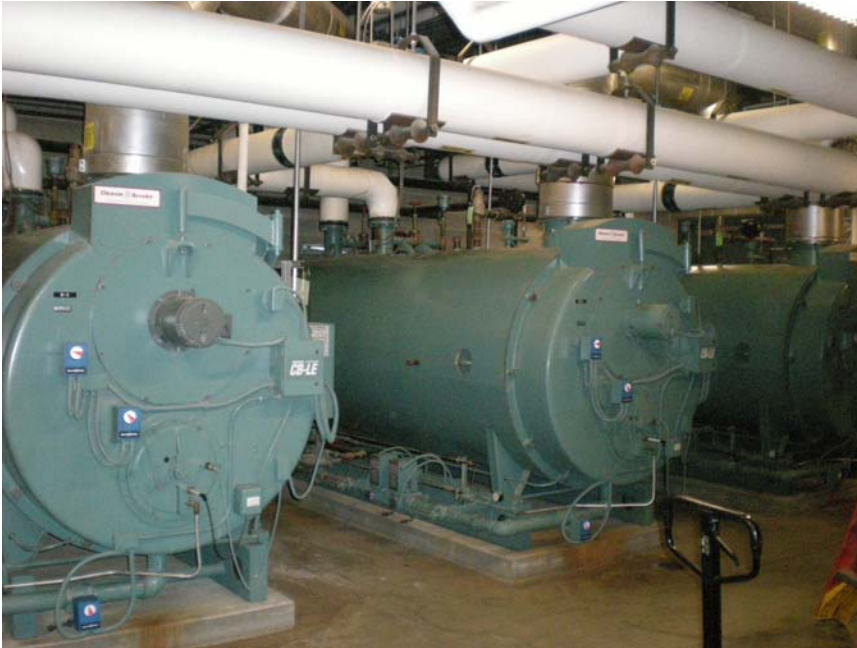
A dedicated make-up air handling unit (AHU-15) provides combustion air for the boilers. It is our understanding that this make-up air system has been problematic in operation due to freeze stat trips and equipment lock-out. Dampers are typically locked open to provide combustion air.

Heating Plant – Three Fire Tube Boilers (2004 Installation)

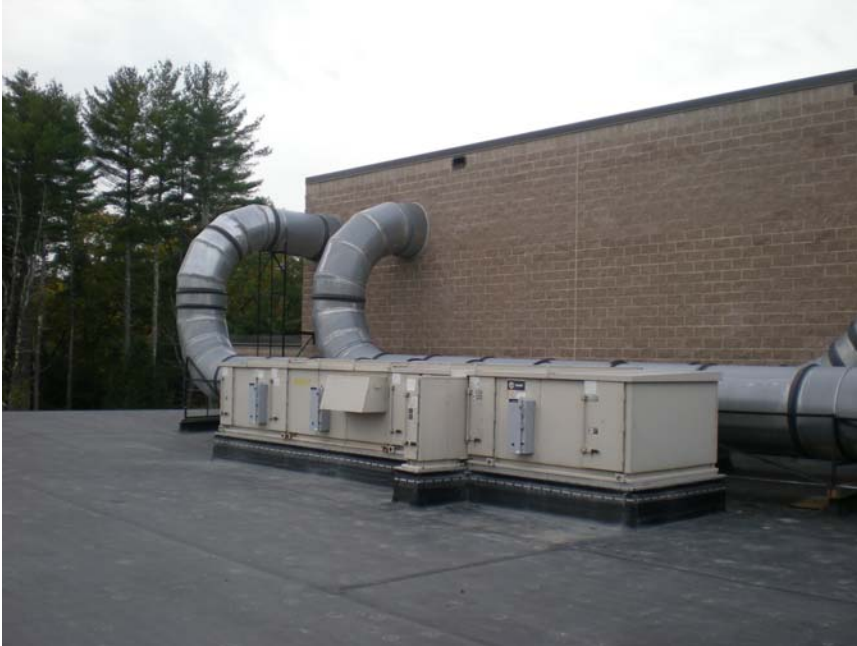
Typical Rooftop Air Handling Unit and exposed ductwork (2004 Installation)

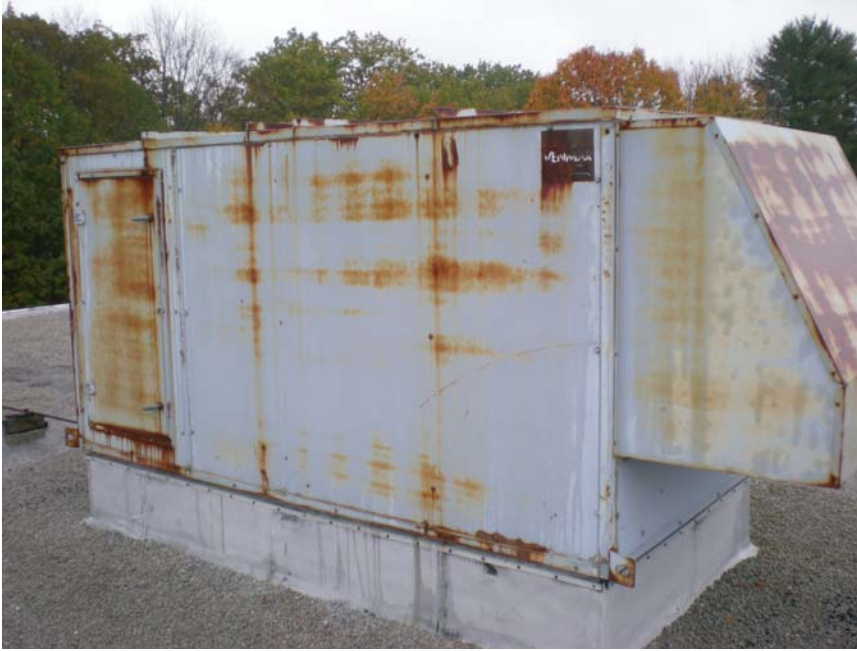
Ventilation is provided to most locations within the building by rooftop energy recovery units (ERV's) installed during 1995 renovations. Supply and exhaust duct networks are routed from each ERV to spaces served.

Typical Energy Recovery Ventilation Unit (1995 Installation)

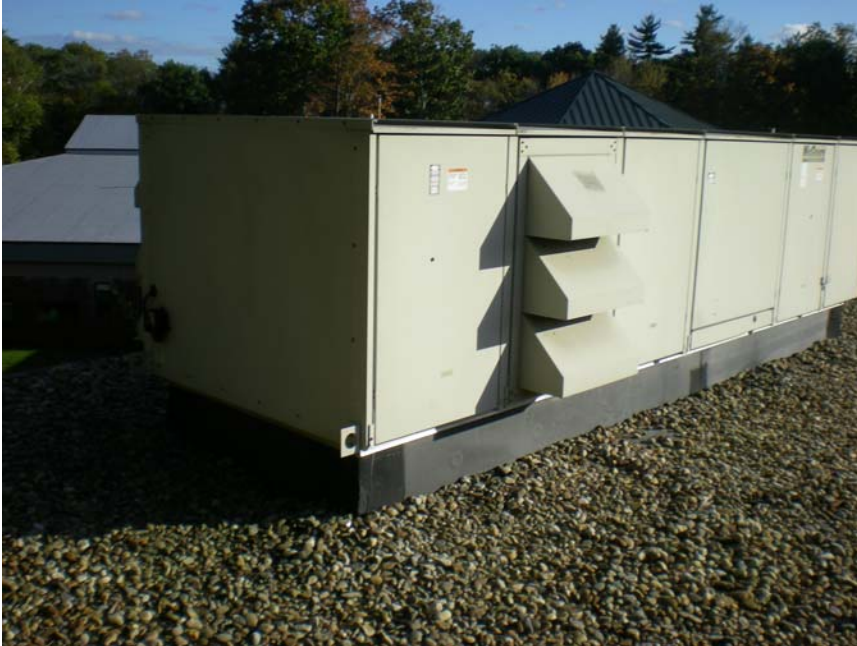
No direct make-up air system is provided for the kitchen. The grease hood exhaust fan and dishwasher hood exhaust fan total 3,750 CFM airflow (2,750 CFM and 1,000 CFM fans). During

operation, significant negative pressurization is expected in the kitchen and adjacent areas. It appears that some effort has been made to control differential pressure between the kitchen and Multi-Purpose Room by modulating dampers in the rooftop ventilation unit serving the Multi-Purpose Room – however, this control is likely ineffective due to the free connectivity of the two spaces (i.e. sensor will not detect significant differential pressure between the two spaces because they are open to each other through the dishwashing area pass-through window).

Multi-Purpose Room Roof Top Ventilation Unit (1989 Installation)

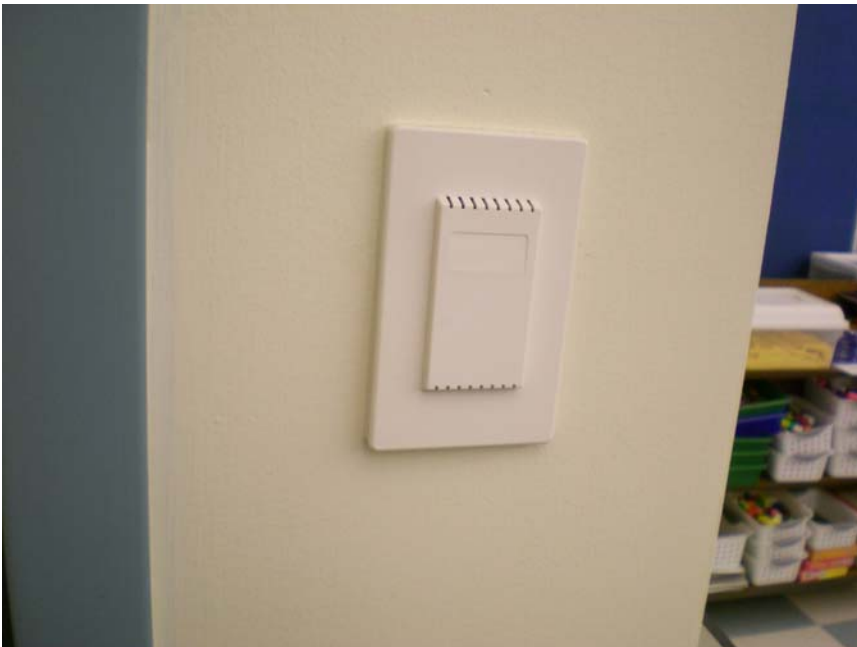
Typical CO2 sensor – mounted on wall

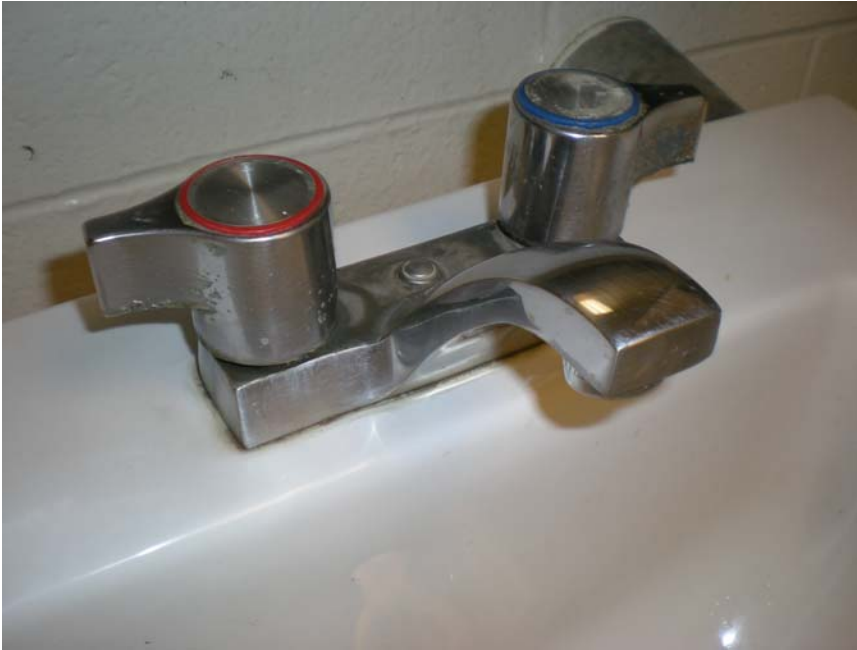
Plumbing fixtures throughout the facility remain from the original 1989 construction (although identified in 5-yr Capital Improvement Plan for upgrade to electronic hard wired fixtures/valves for FY10).

Typical lavatory faucet

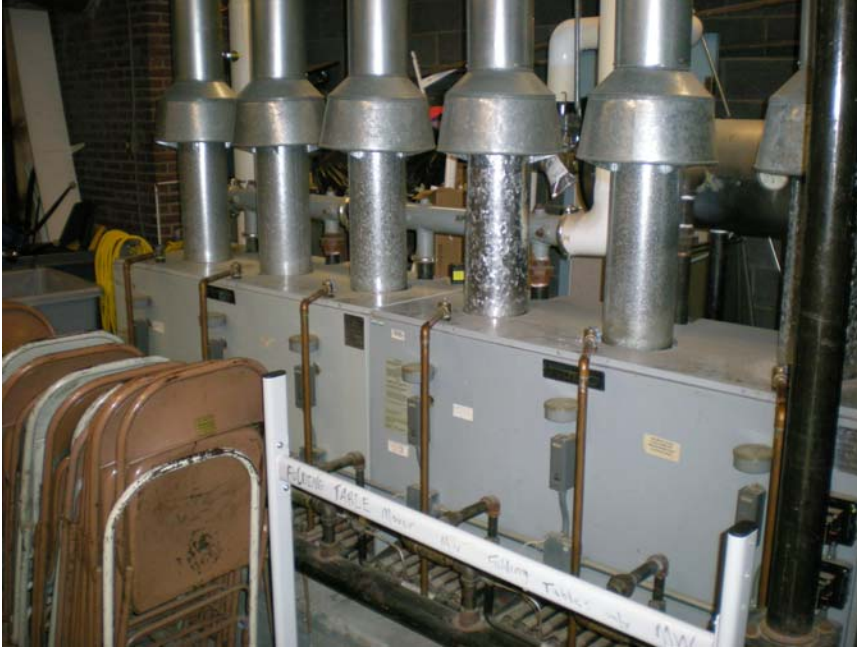
Modular Cast Iron Boilers with atmospheric burners (1991 Date of Manufacture)

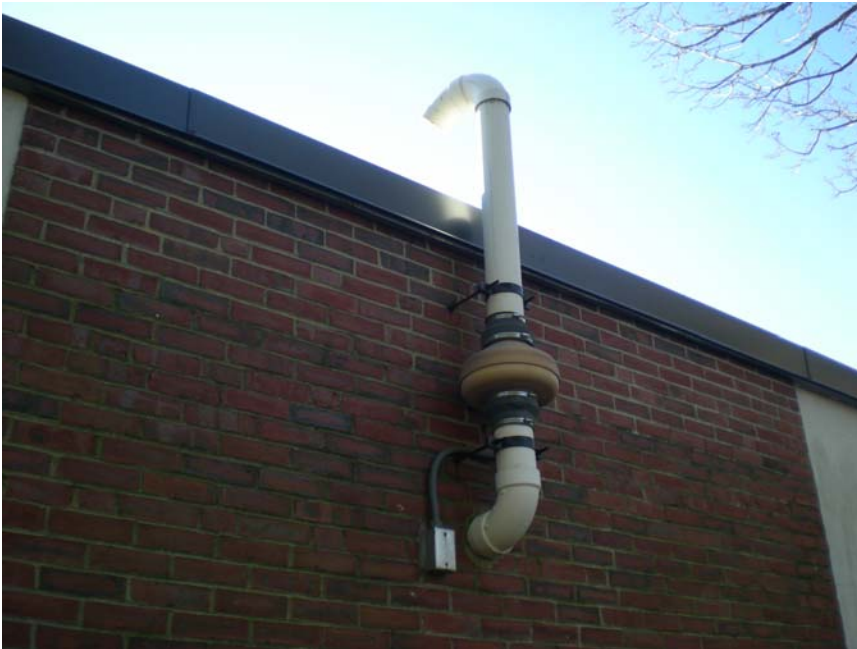
Several radon vent systems were observed on the north wing – these systems consist of small in-line fans with PVC piping in to the area below the concrete floor slab to de-pressurize the sub-slab area.

Typical Radon Vent System at North Wing – Fan Powered
