EMANUEL ENGINEERING, INC.

March 13, 2015

RE: Roof Snow Loads
Moharimet Elementary School
Oyster River Cooperative School District
Madbury, NH

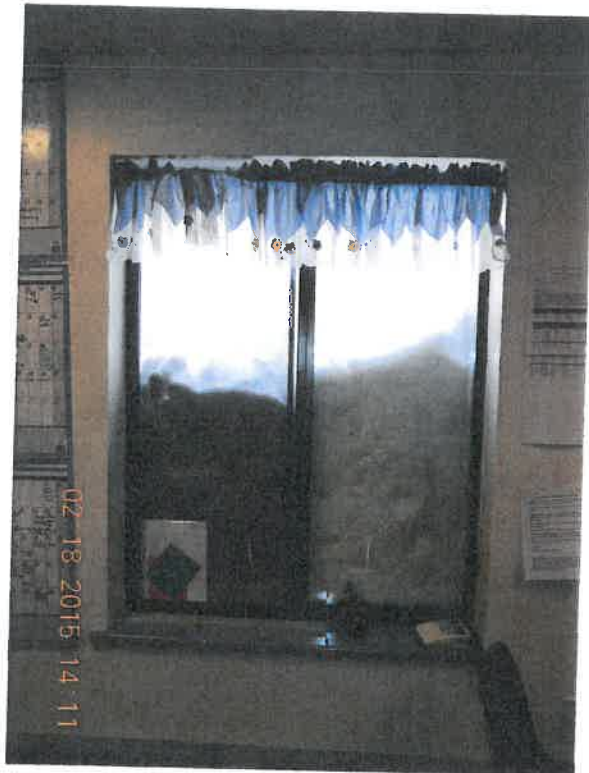
Room:	Observations – Comments:
155	Observed vertical crack at juncture of masonry wall and interior drywall face of the exterior metal framed wall. Both walls are non-load bearing and independent of each other. Believed to be unrelated to current snow load conditions and crack is not of structural significance. Concerned with snow loading resulting from snow piling against window units.

Room 155 - vertical crack at joint of 2 dissimilar walls

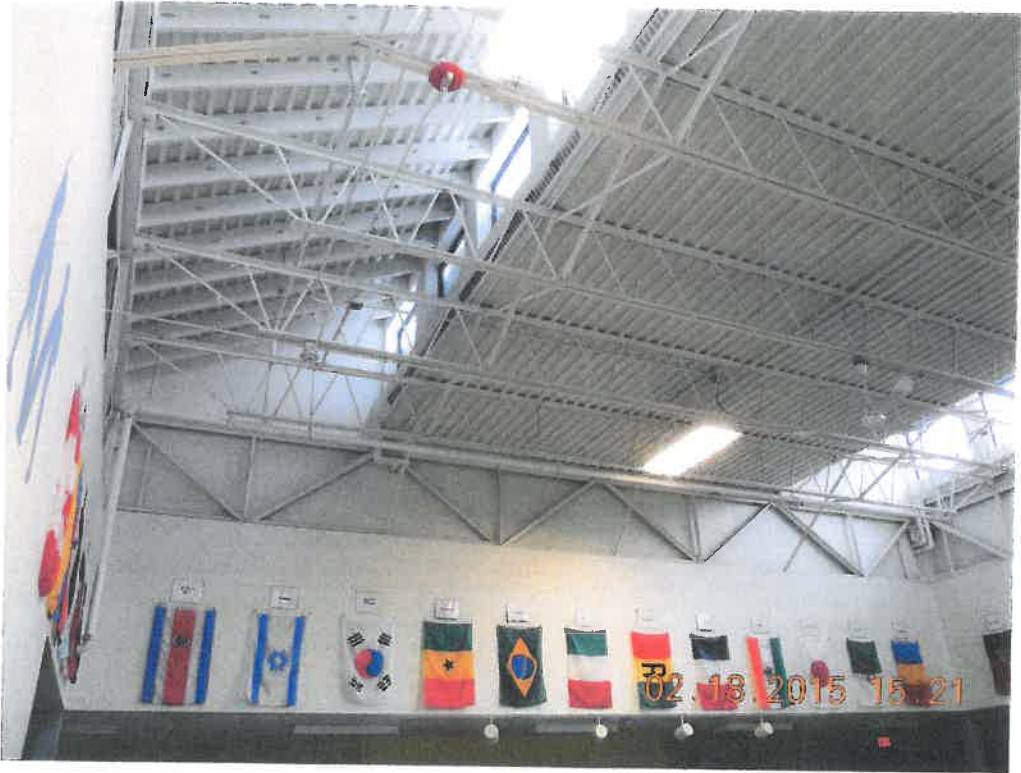
**East Commons - roof joists exhibited
and measured no significant sag.**

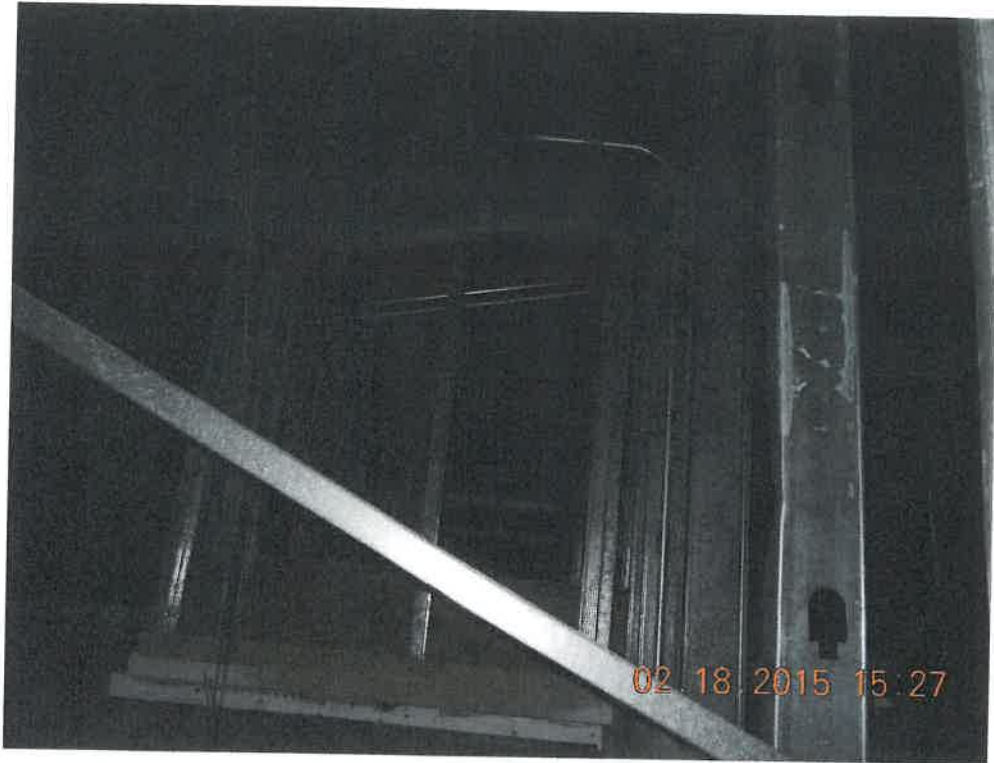
Wall track fastened directly to steel bar joist.

- Drywall cracks may be repaired but will reoccur when excessive snow loads occur on the roof unless the light gage metal framing is modified by using proper deflection tracks at the top of the wall above the observed cracks.
- All roof drains shall be kept free of snow to allow for snow melt.

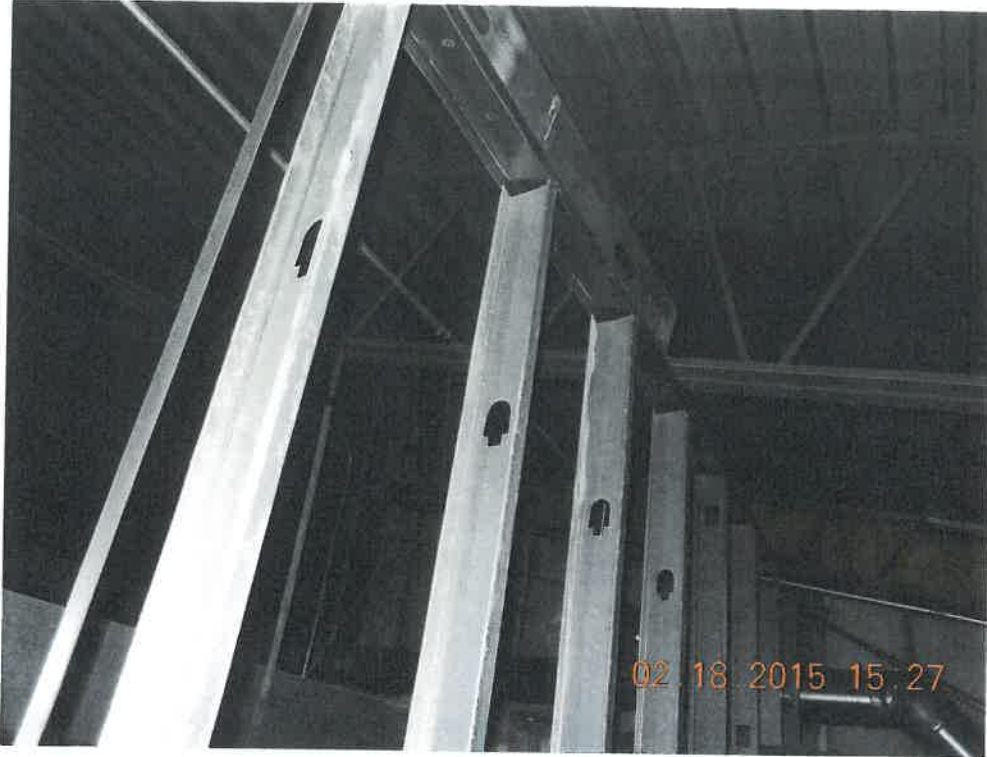
Metal stud wall allows for no movement of roof joists.
